**SECTION 38 (1) PLANNING (LISTED BUILDINGS AND CONSERVATION AREAS) ACT 1990**

**LISTED BUILDING ENFORCEMENT NOTICE**

Land at 1-3 Bethlehem Street, Grimsby, North East Lincolnshire, DN31 1JN, (“the building”) shown edged in red on the attached plan.

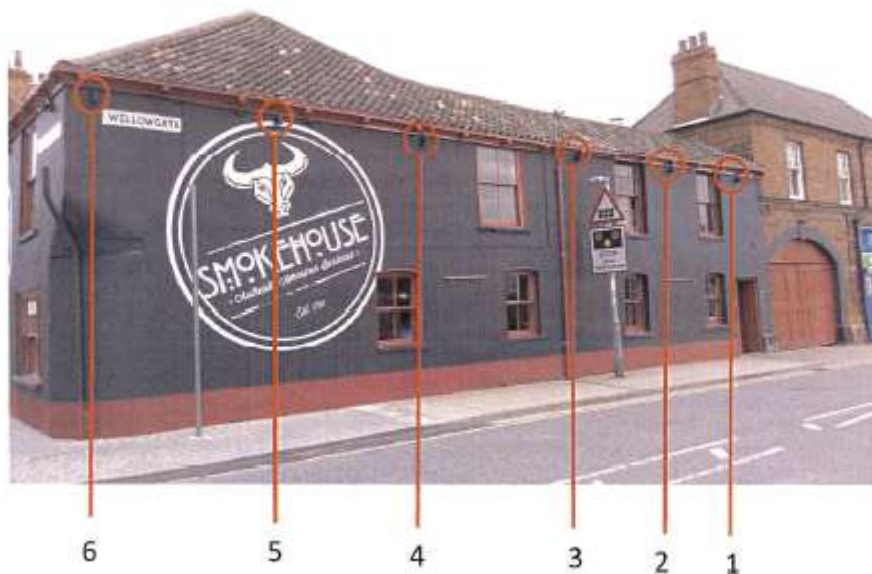
- 3.3    The re-painting of the rendered plinth in red from black (Photo 7).
- 3.4    The addition of 12 exterior down lights and associated wiring (see Photos 1 and 2).

Photo 1 – Showing lights 1 – 6 on Wellowgate

5.1 Remove all 12 external lights (see Photo 1 and Photo 2), their fittings and electricity supply (using a competent and approved electrician).

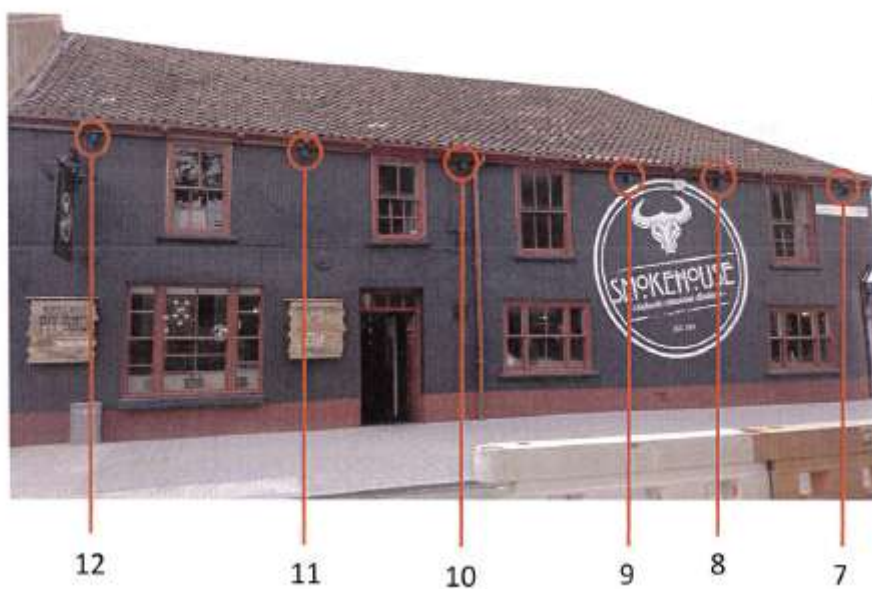
Photo 2 – Showing lights 7 – 12 on Bethlehem Street

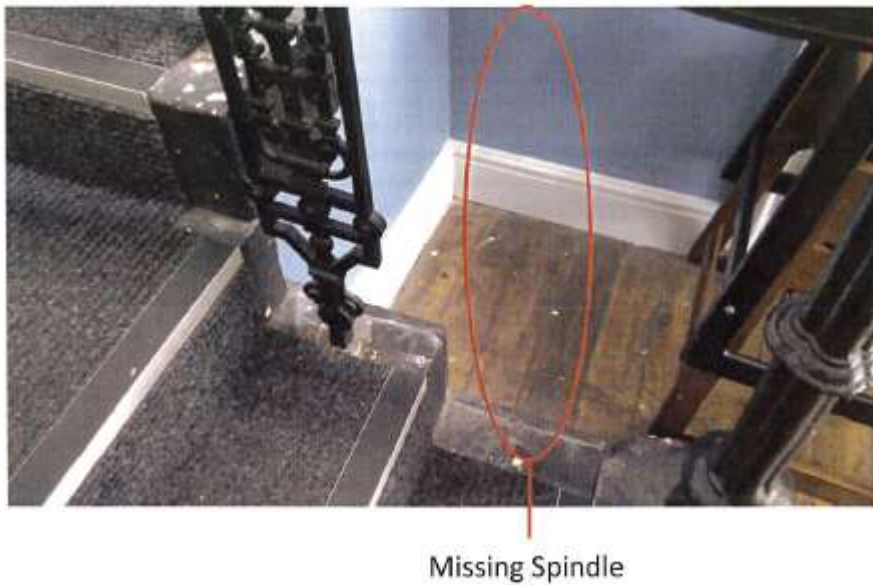
replaced incorrectly (see Photo 10) and 1 being missing (see Photo 8).

Photo 8 – Showing missing spindle (Ground Floor Spindle One)

- 5.10 Locate the missing spindle from Photo 8. If the missing spindle cannot be located create a new spindle matching exactly (in design, size materials and finish) those already in place and insert into the gap making sure not to cause damage to the banister or footplate. The moulded side should face outwards, away from the footplate as per correct spindle in Photo 9.

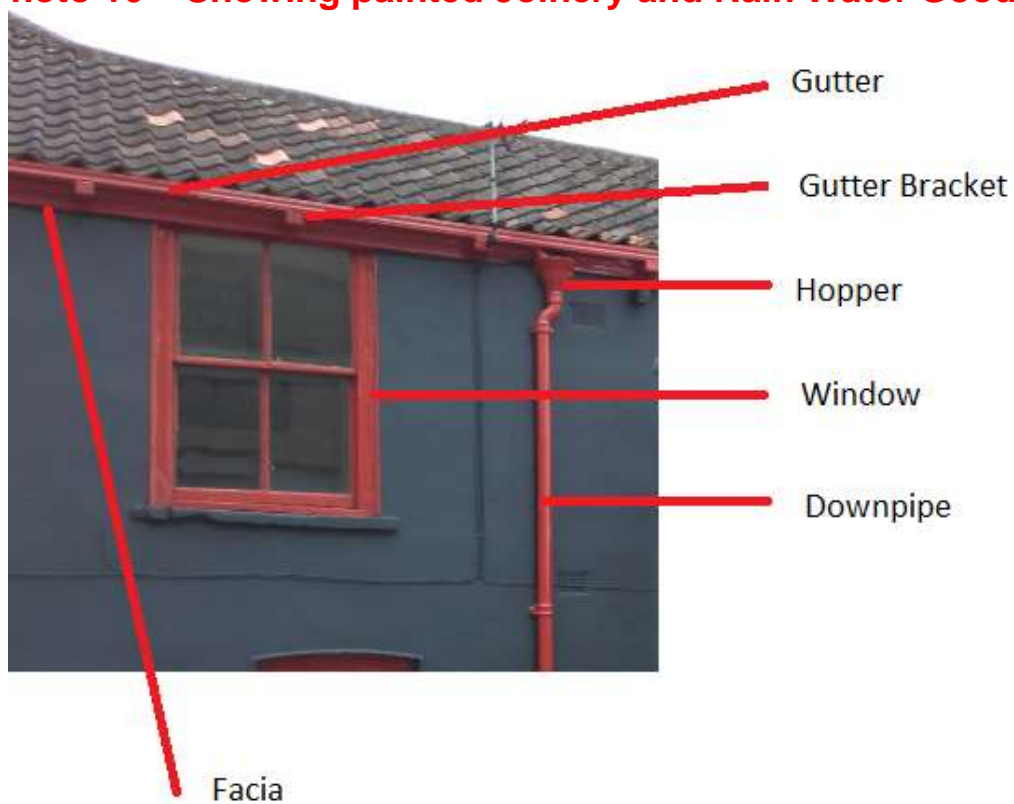
- 3.1    The re-painting of the exterior render and masonry arch in black/grey from white/cream (see Photo 6).
- 3.2    The re-painting of exterior joinery (windows, doors, fascia, gutters and gutter brackets) and rain water goods (hoppers and downpipes) in red from black (see Photo 16).

**Photo 16 – Showing painted Joinery and Rain Water Goods.**

5.4 Remove existing paint to joinery (windows, doors, fascia, gutters and gutter brackets) using an appropriate method and following manufacturers guidelines. Ease windows ensuring these are capable of being opened. Re-fix loose or replace broken glazing 'like for like' and fix with putty.

- 5.7 Repaint joinery (windows, doors, fascia, gutters and gutter brackets) in black gloss having first appropriately primed, ensuring to paint over the glazing putty for a weather tight seal.

- 5.8 Re-paint rainwater goods (hoppers and downpipes) in black gloss.
- 5.9 Reinstall painted plinth in black gloss which is level with the masonry plinth which includes painting the masonry plinth at the base of the arch to the footpath (see Photo 7).

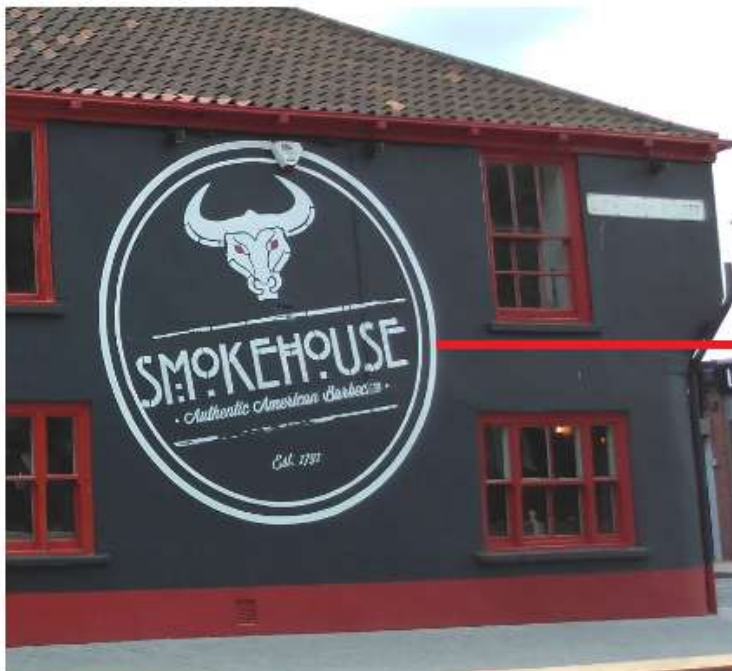
- 3.5    The addition of 2 exterior painted SMOKEHOUSE advertisements (see Photos 17 and 18).
- 3.6    The addition of 4 hanging apparatus which are used for the display of advertisements (see Photos 3 and 4).

**Photo 18 – Showing painted SMOKEHOUSE sign on Bethlehem Street elevation.**

Painted SMOKEHOUSE sign

5.5 Remove current paint from the external render and masonry using an appropriate method following manufacturers guidelines. This includes removing the two hand painted smokehouse signs. Once clean and dry any holes or cracks in
