**LISTED BUILDING ENFORCEMENT NOTICE**

Land at 1-3 Bethlehem Street, Grimsby, North East Lincolnshire, DN31 1JN, (“the building”) shown edged in red on the attached plan.

3.     **THE MATTERS WHICH ARE ALLEGED TO CONTRAVENE SECTION 9 OF THE ACT:**

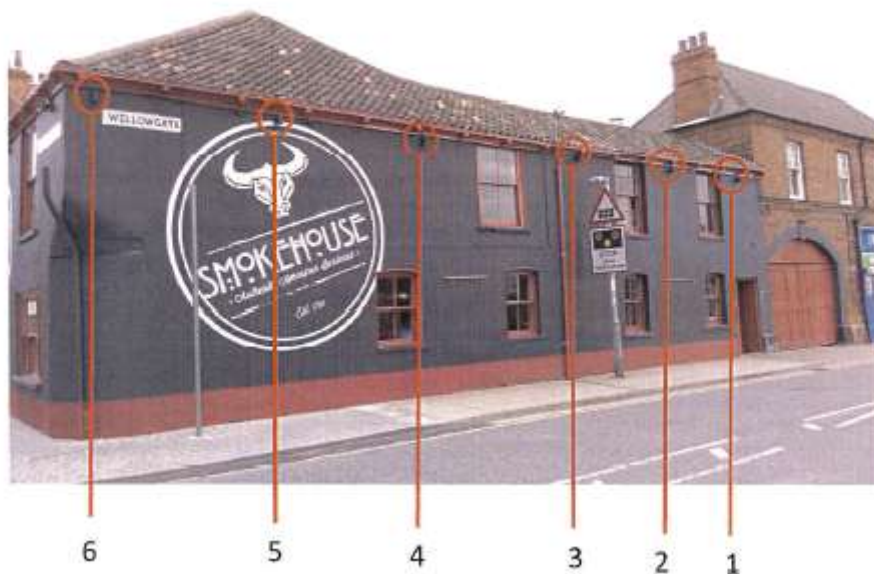
- 3.3    The re-painting of the rendered plinth in red from black (Photo 7).
- 3.4    The addition of 12 exterior down lights and associated wiring (see Photos 1 and 2).

Photo 1 – Showing lights 1 – 6 on Wellowgate

5.1 Remove all 12 external lights (see Photo 1 and Photo 2), their fittings and electricity supply (using a competent and approved electrician).

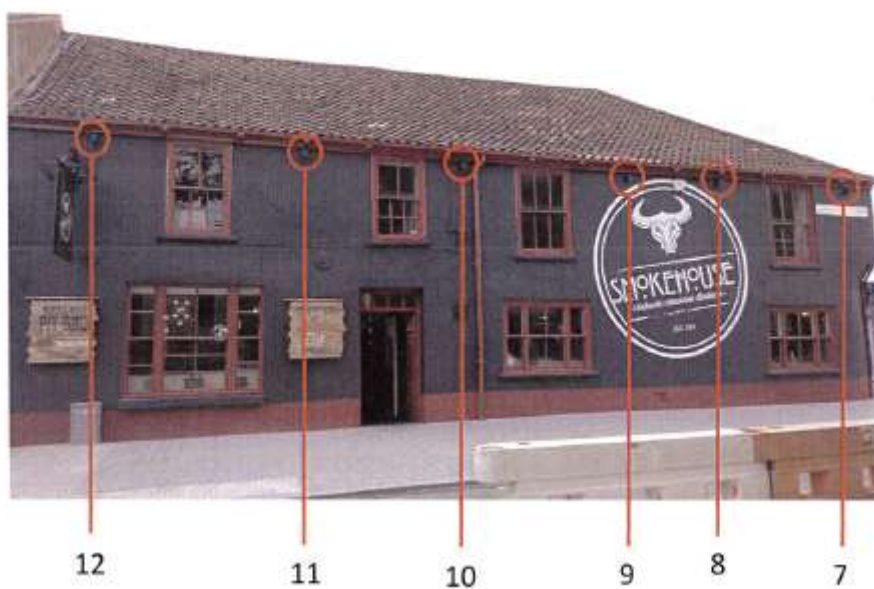
Photo 2 – Showing lights 7 – 12 on Bethlehem Street

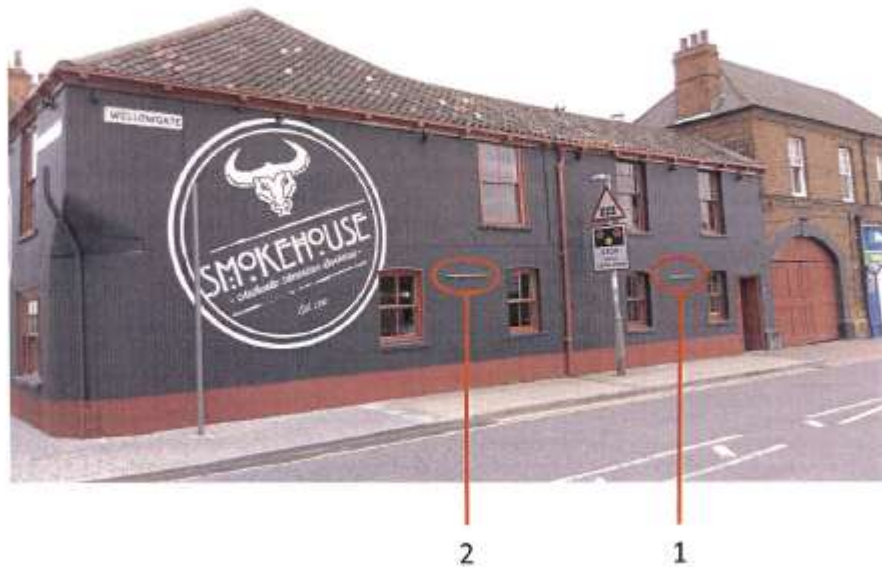
- 3.5    The addition of 2 exterior painted SMOKEHOUSE advertisements (see Photos 17 and 18).
- 3.6    The addition of 4 hanging apparatus which are used for the display of advertisements (see Photos 3 and 4).

Photo 3 – Showing copper hanging rails 1 & 2 on Wellowgate

5.2 Remove 4 external copper hanging rails and fixings which are used to display advertisements (see Photo 3 and Photo 4).

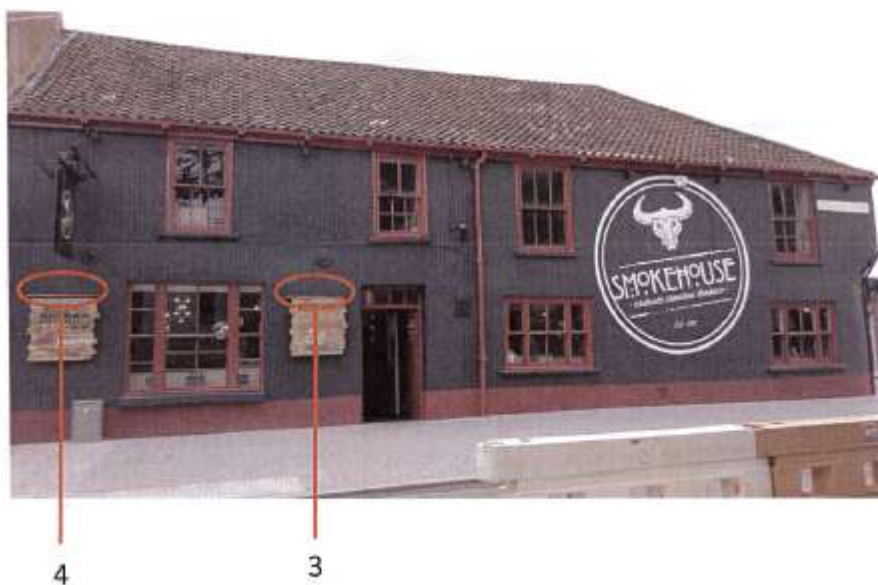
Photo 4 – Showing cooper hanging rails 3 and 4 on Bethlehem Street

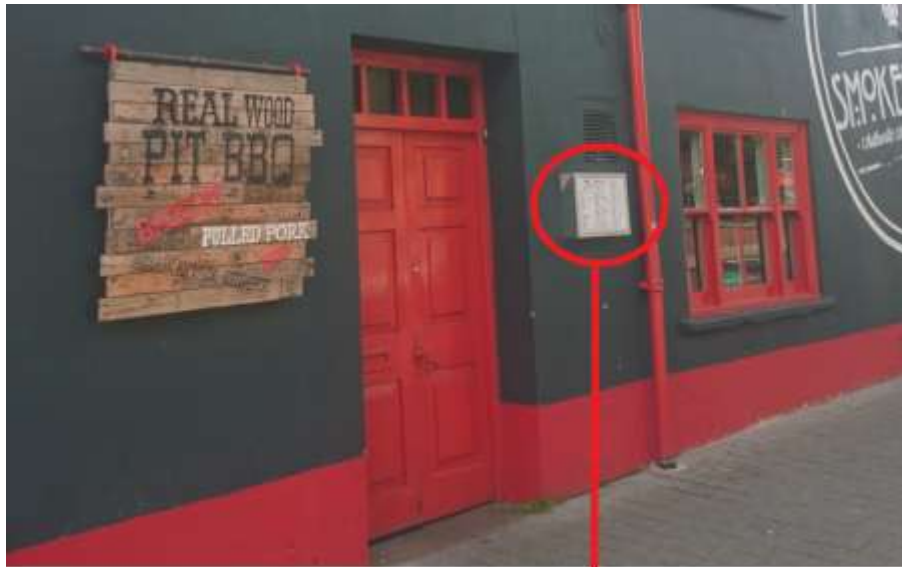
- 3.7    The addition of a chrome cased advertisement to the right of the main entrance door which houses the restaurant menu (see Photo 5).
- 3.8    The disassembly of the main staircase spindles and banister and its incorrect reassembly leading to 7 of its spindles being

Photo 5 – Showing Chrome menu Display Box

5.3 Remove the chrome box used to display restaurant menu (see Photo 5) and its fixings.

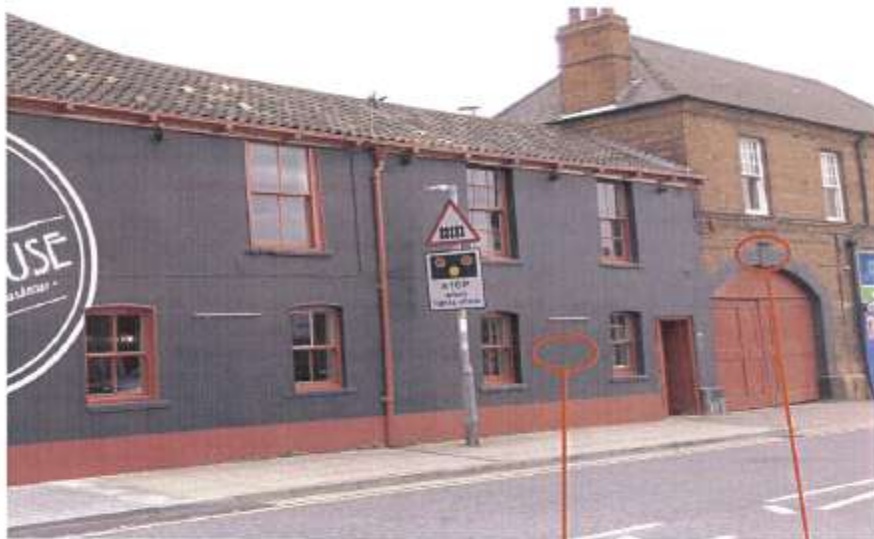
- 3.1    The re-painting of the exterior render and masonry arch in black/grey from white/cream (see Photo 6).
- 3.2    The re-painting of exterior joinery (windows, doors, fascia, gutters and gutter brackets) and rain water goods (hoppers and downpipes) in red from black (see Photo 16).

Photo 6 – Showing Wellowgate elevation including masonry arch

5.5 Remove current paint from the external render and masonry using an appropriate method following manufacturers guidelines. This includes removing the two hand painted smokehouse signs. Once clean and dry any holes or cracks in

- 5.6 Prime and paint exterior render and masonry arch excluding the plinth (see Photo 6) in a water based masonry paint for example Little Greene, Masonry Paint, colour to be off white/cream or similar, using a minimum of 2 coats according to the manufacturers guidelines until fully and evenly covered.

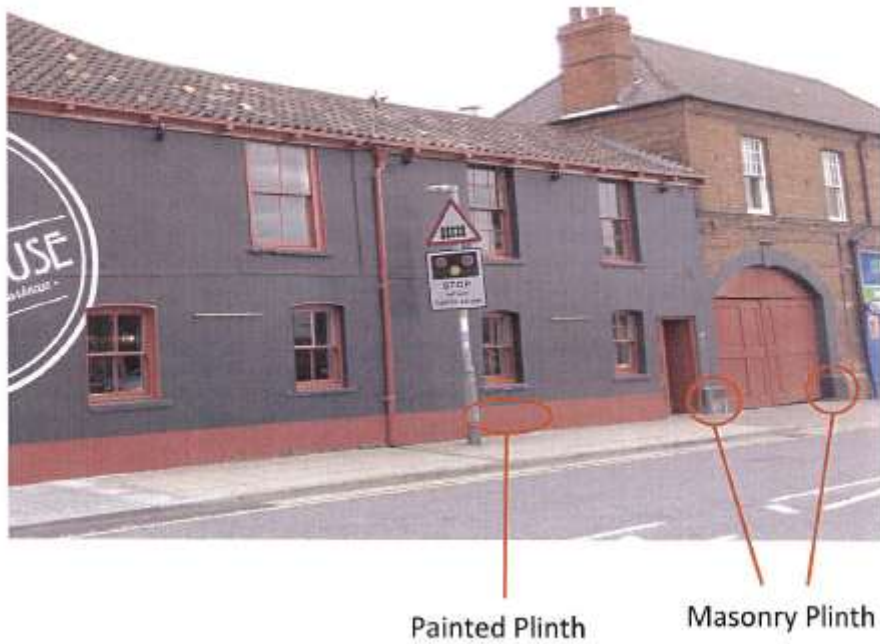
Photo 7 – Showing Wellowgate elevation including masonry plinth and painted plinth

- 5.8 Re-paint rainwater goods (hoppers and downpipes) in black gloss.
- 5.9 Reinstall painted plinth in black gloss which is level with the masonry plinth which includes painting the masonry plinth at the base of the arch to the footpath (see Photo 7).

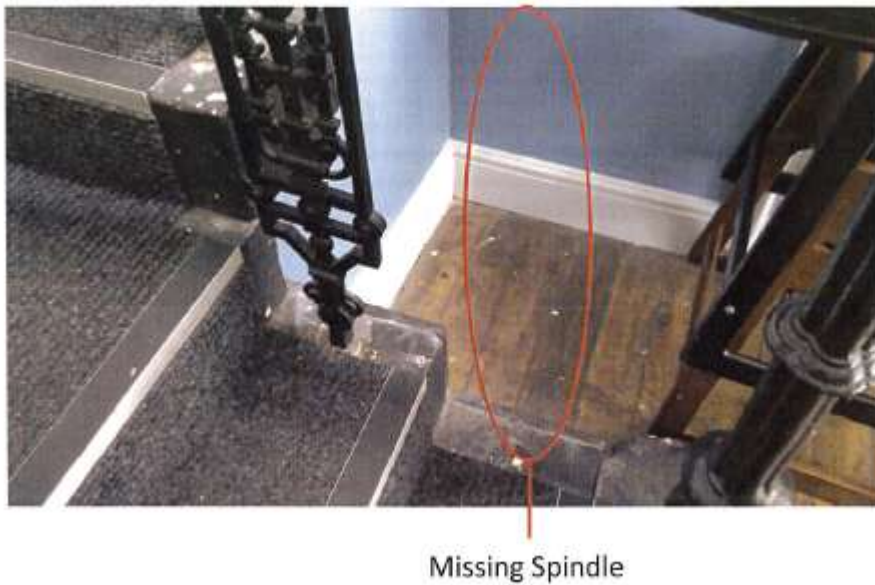
replaced incorrectly (see Photo 10) and 1 being missing (see Photo 8).

Photo 8 – Showing missing spindle (Ground Floor Spindle One)

- 5.10 Locate the missing spindle from Photo 8. If the missing spindle cannot be located create a new spindle matching exactly (in design, size materials and finish) those already in place and insert into the gap making sure not to cause damage to the banister or footplate. The moulded side should face outwards, away from the footplate as per correct spindle in Photo 9.

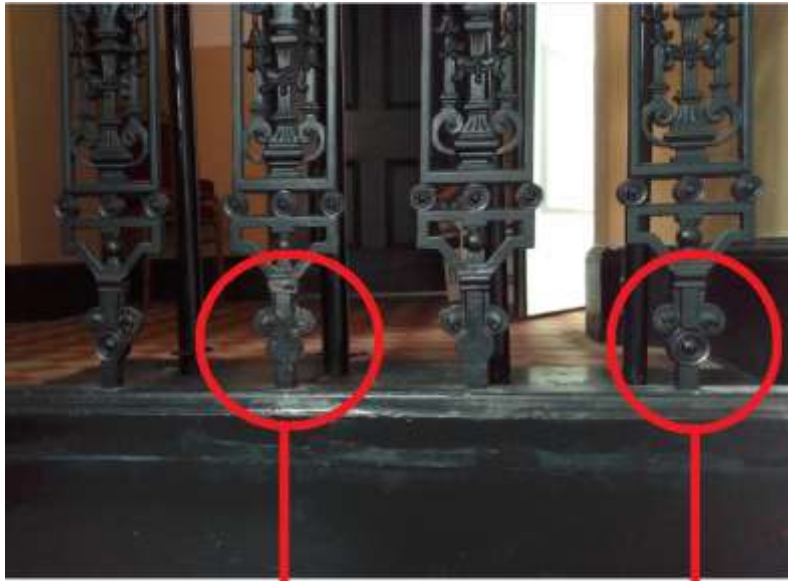
Photo 9 – Showing orientation of spindles

Incorrect facing  
spindle – mould  
facing the footplate.

Correct facing  
spindle – mould  
facing away from  
the footplate.

- 5.11 Carefully remove the 7 spindles which are orientated incorrectly (see Photo 10) making sure the banister and footplate is not damaged. Replace these spindles so that they match the remaining spindles (see Photo 9) in orientation.

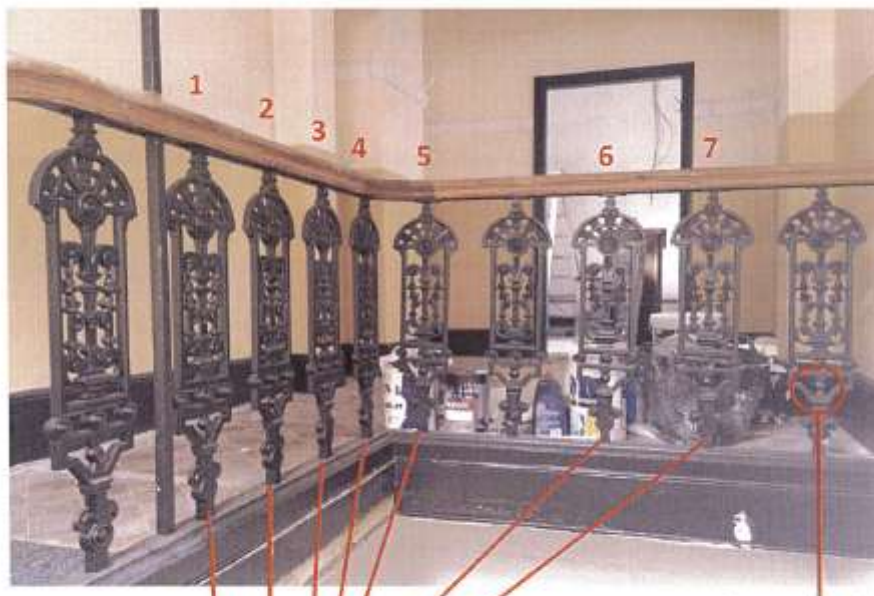
Photo10 – Showing incorrect facing incl  
incorrect facing spindles

In Incorrect facing spindles – mould  
facing the footplate.

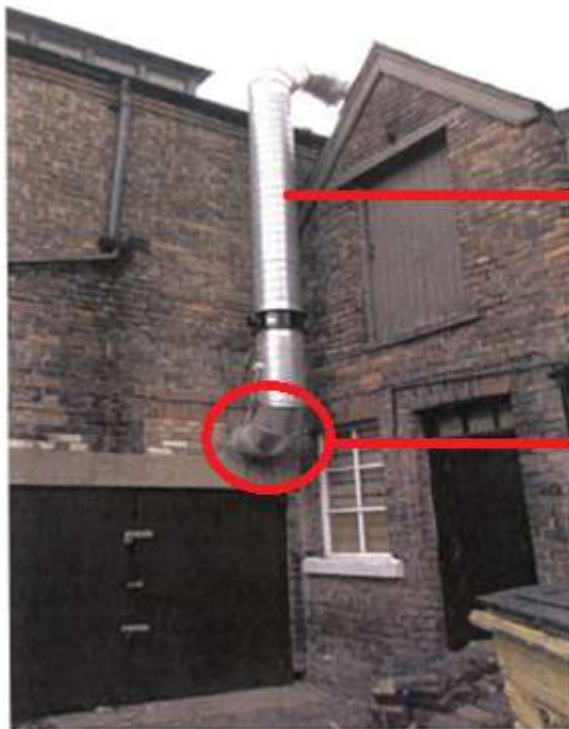
3.10 The installation of 2 large flues and subsequent creation of 2 large holes in the brickwork to accommodate these (see Photo 11 and 12).

Photo 11– Showing extraction flue A

Hole in brickwork  
where flue exits the  
building.

- 5.12 Remove external flues and fixings (see Photo 11 and Photo 12). Using matching brickwork (matching brick, matching bond and matching lime mortar) repair holes in walls where each flue exited the building and repoint any areas of damage where the flue was fixed to the building.

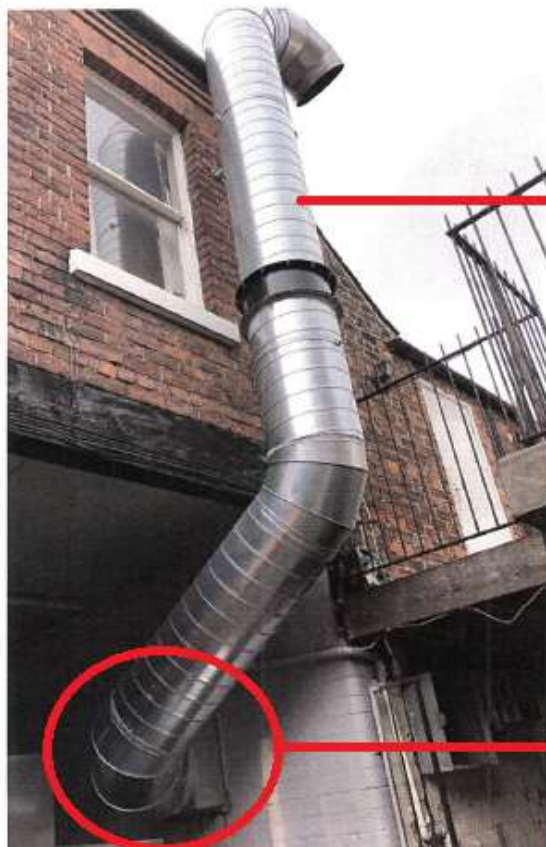
Photo 12 – Showing extraction flue B

Hole in brickwork  
where flue exits  
the building.

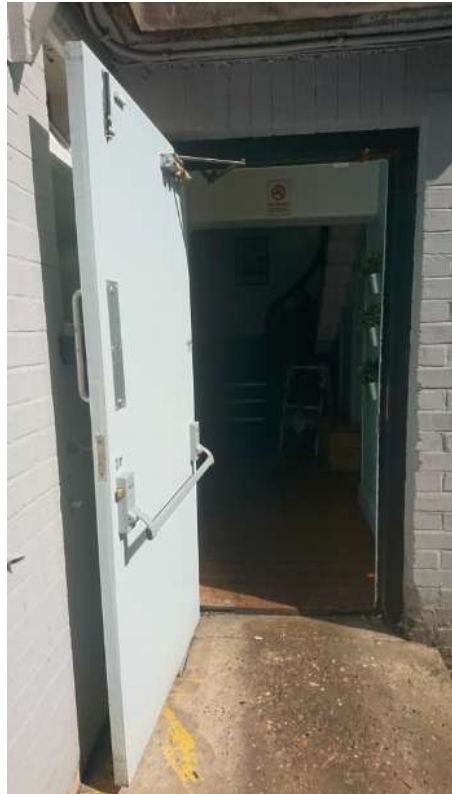
3.9 The removal and replacement of 2 external doors to the ground floor (see Photo 13 and Photo 14).

Photo 13 – External Door leading to stairwell.

- 5.13 Remove 2 external doors (see Photo 13 and 14) and replace with doors to match those removed (see Photo 15), timber ledged and braced painted in black gloss.

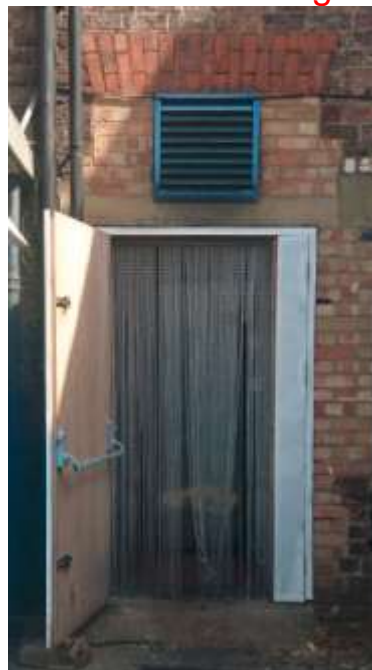
Photo 14 – External Door leading to kitchen/store.

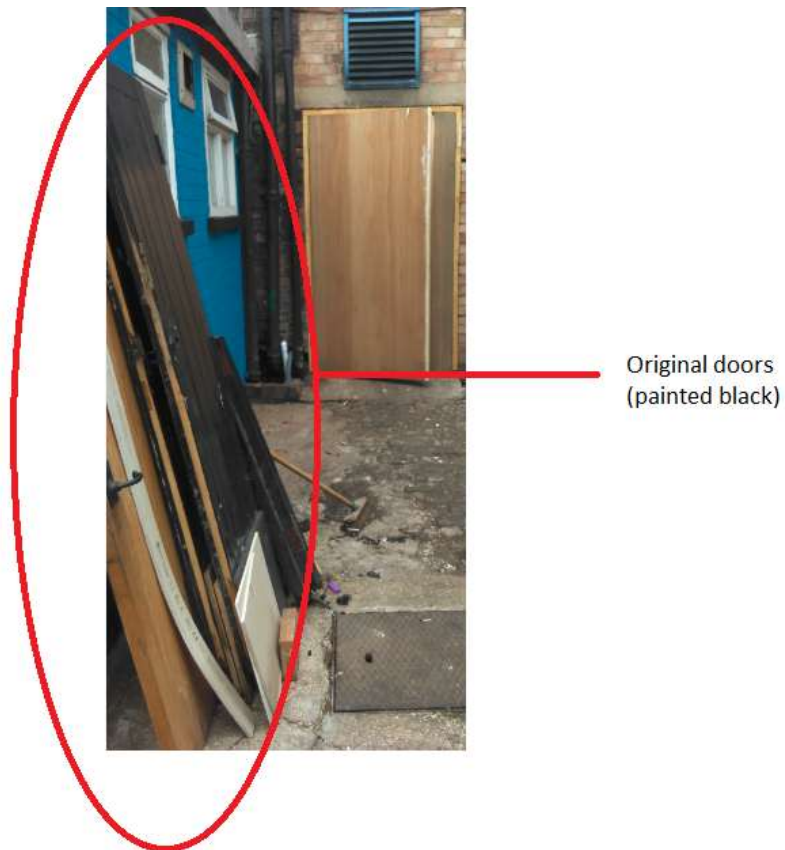
Photo 15 – Original doors being removed during works.

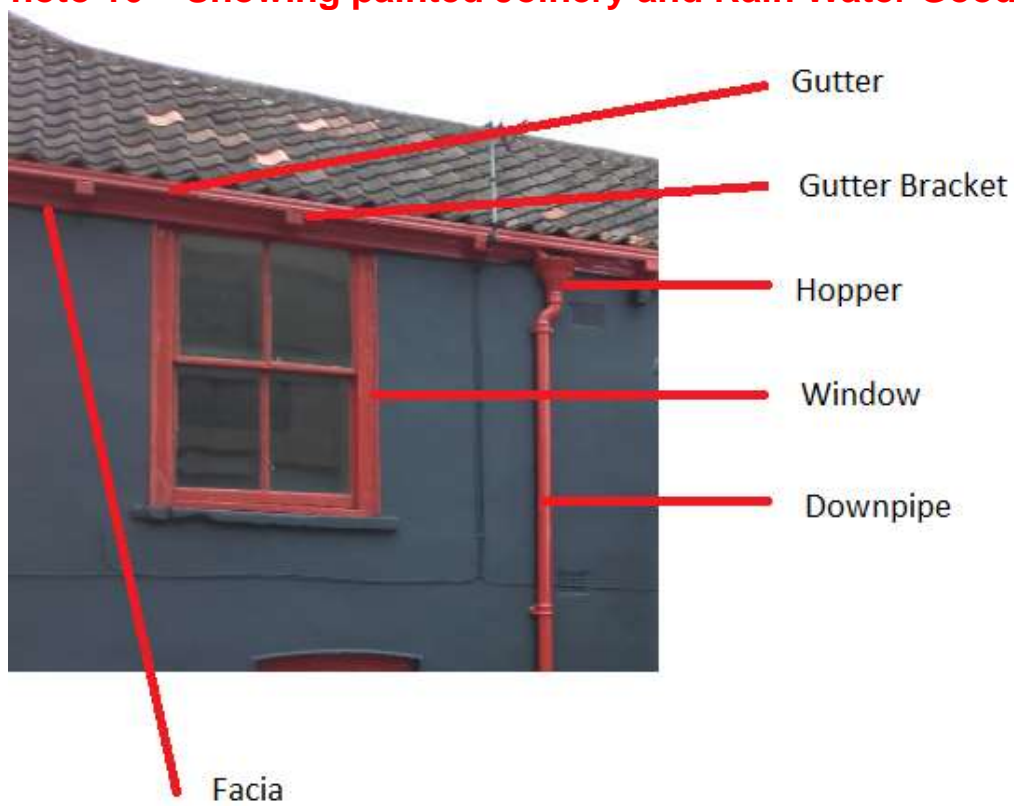
**Photo 16 – Showing painted Joinery and Rain Water Goods.**

5.4 Remove existing paint to joinery (windows, doors, fascia, gutters and gutter brackets) using an appropriate method and following manufacturers guidelines. Ease windows ensuring these are capable of being opened. Re-fix loose or replace broken glazing 'like for like' and fix with putty.

- 5.7 Repaint joinery (windows, doors, fascia, gutters and gutter brackets) in black gloss having first appropriately primed, ensuring to paint over the glazing putty for a weather tight seal.

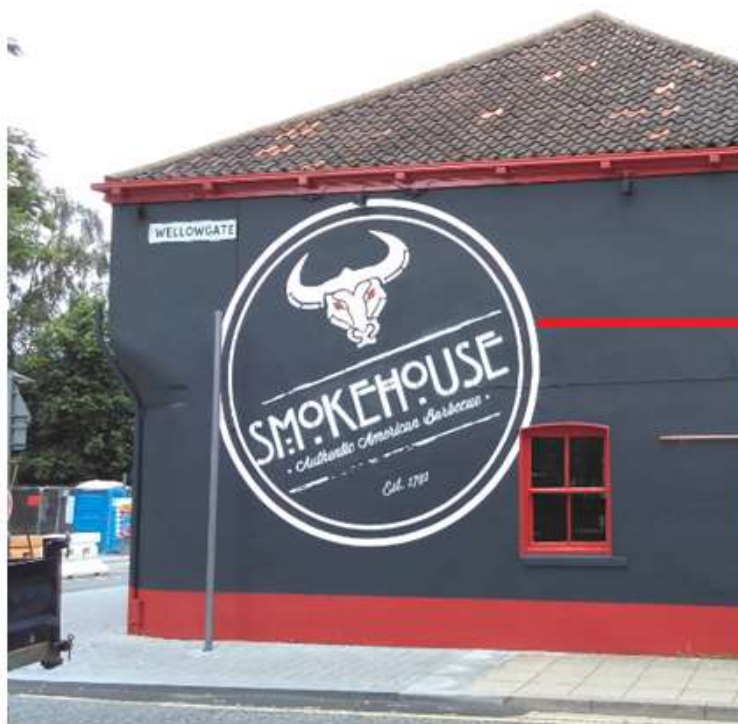
**Photo 17 – Showing painted SMOKEHOUSE sign on Wellowgate elevation.**

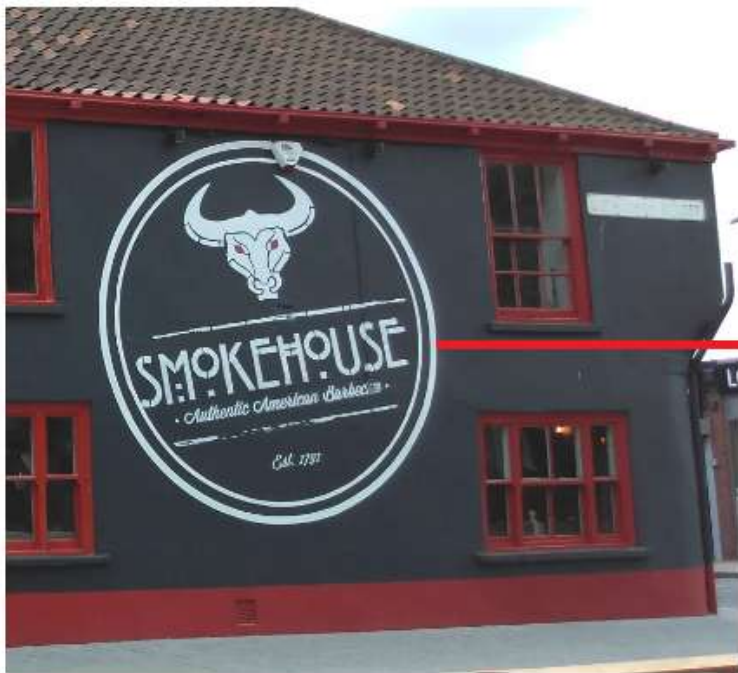
**Photo 18 – Showing painted SMOKEHOUSE sign on  
Bethlehem Street elevation.**
