**LISTED BUILDING ENFORCEMENT NOTICE**

**ISSUED BY:**        **NORTH EAST LINCOLNSHIRE COUNCIL**

Land at 1-3 Bethlehem Street, Grimsby, North East Lincolnshire, DN31 1JN, (“the building”) shown edged in red on the attached plan.

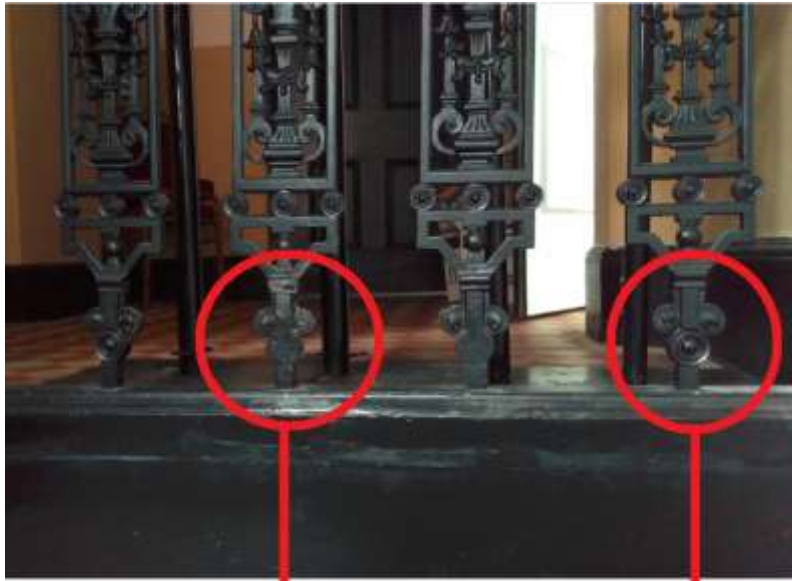
Photo 9 – Showing orientation of spindles

Incorrect facing  
spindle – mould  
facing the footplate.

Correct facing  
spindle – mould  
facing away from  
the footplate.

- 5.11 Carefully remove the 7 spindles which are orientated incorrectly (see Photo 10) making sure the banister and footplate is not damaged. Replace these spindles so that they match the remaining spindles (see Photo 9) in orientation.

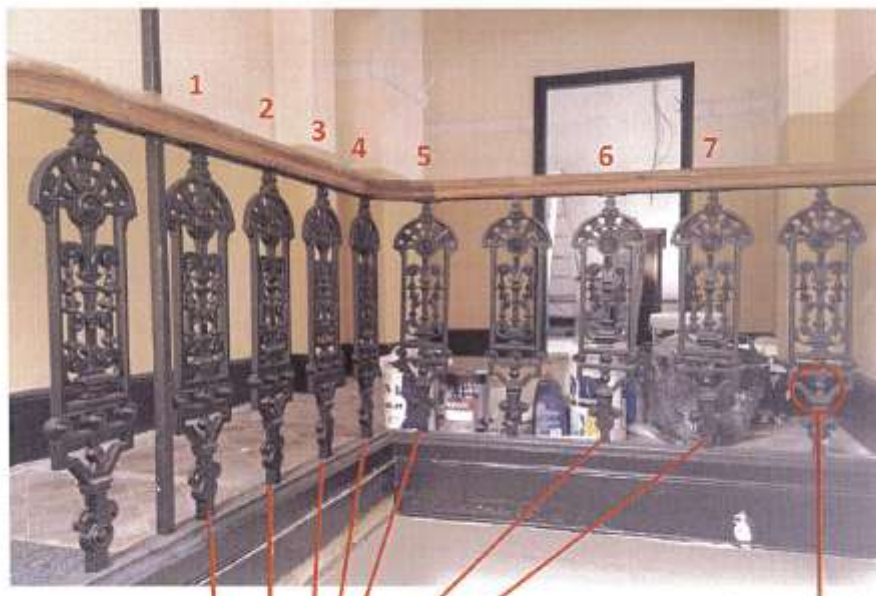
- 3.7    The addition of a chrome cased advertisement to the right of the main entrance door which houses the restaurant menu (see Photo 5).
- 3.8    The disassembly of the main staircase spindles and banister and its incorrect reassembly leading to 7 of its spindles being

replaced incorrectly (see Photo 10) and 1 being missing (see Photo 8).

Photo10 – Showing incorrect facing incl  
incorrect facing spindles

In Incorrect facing spindles – mould  
facing the footplate.

Correct facing  
spindle – mould  
facing away from  
the footplate.

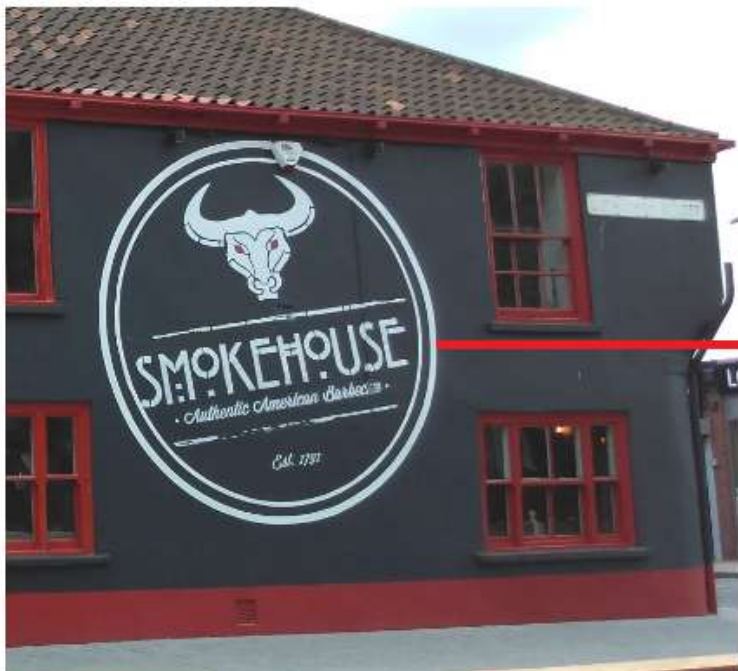
- 3.5    The addition of 2 exterior painted SMOKEHOUSE advertisements (see Photos 17 and 18).
- 3.6    The addition of 4 hanging apparatus which are used for the display of advertisements (see Photos 3 and 4).

**Photo 18 – Showing painted SMOKEHOUSE sign on  
Bethlehem Street elevation.**

5.5 Remove current paint from the external render and masonry using an appropriate method following manufacturers guidelines. This includes removing the two hand painted smokehouse signs. Once clean and dry any holes or cracks in
