## **Section 19 Flood Investigation Report**

**July 20<sup>th</sup>, August 8<sup>th</sup>, August 10<sup>th</sup> 2014**

Flood and Water Management Act 2010

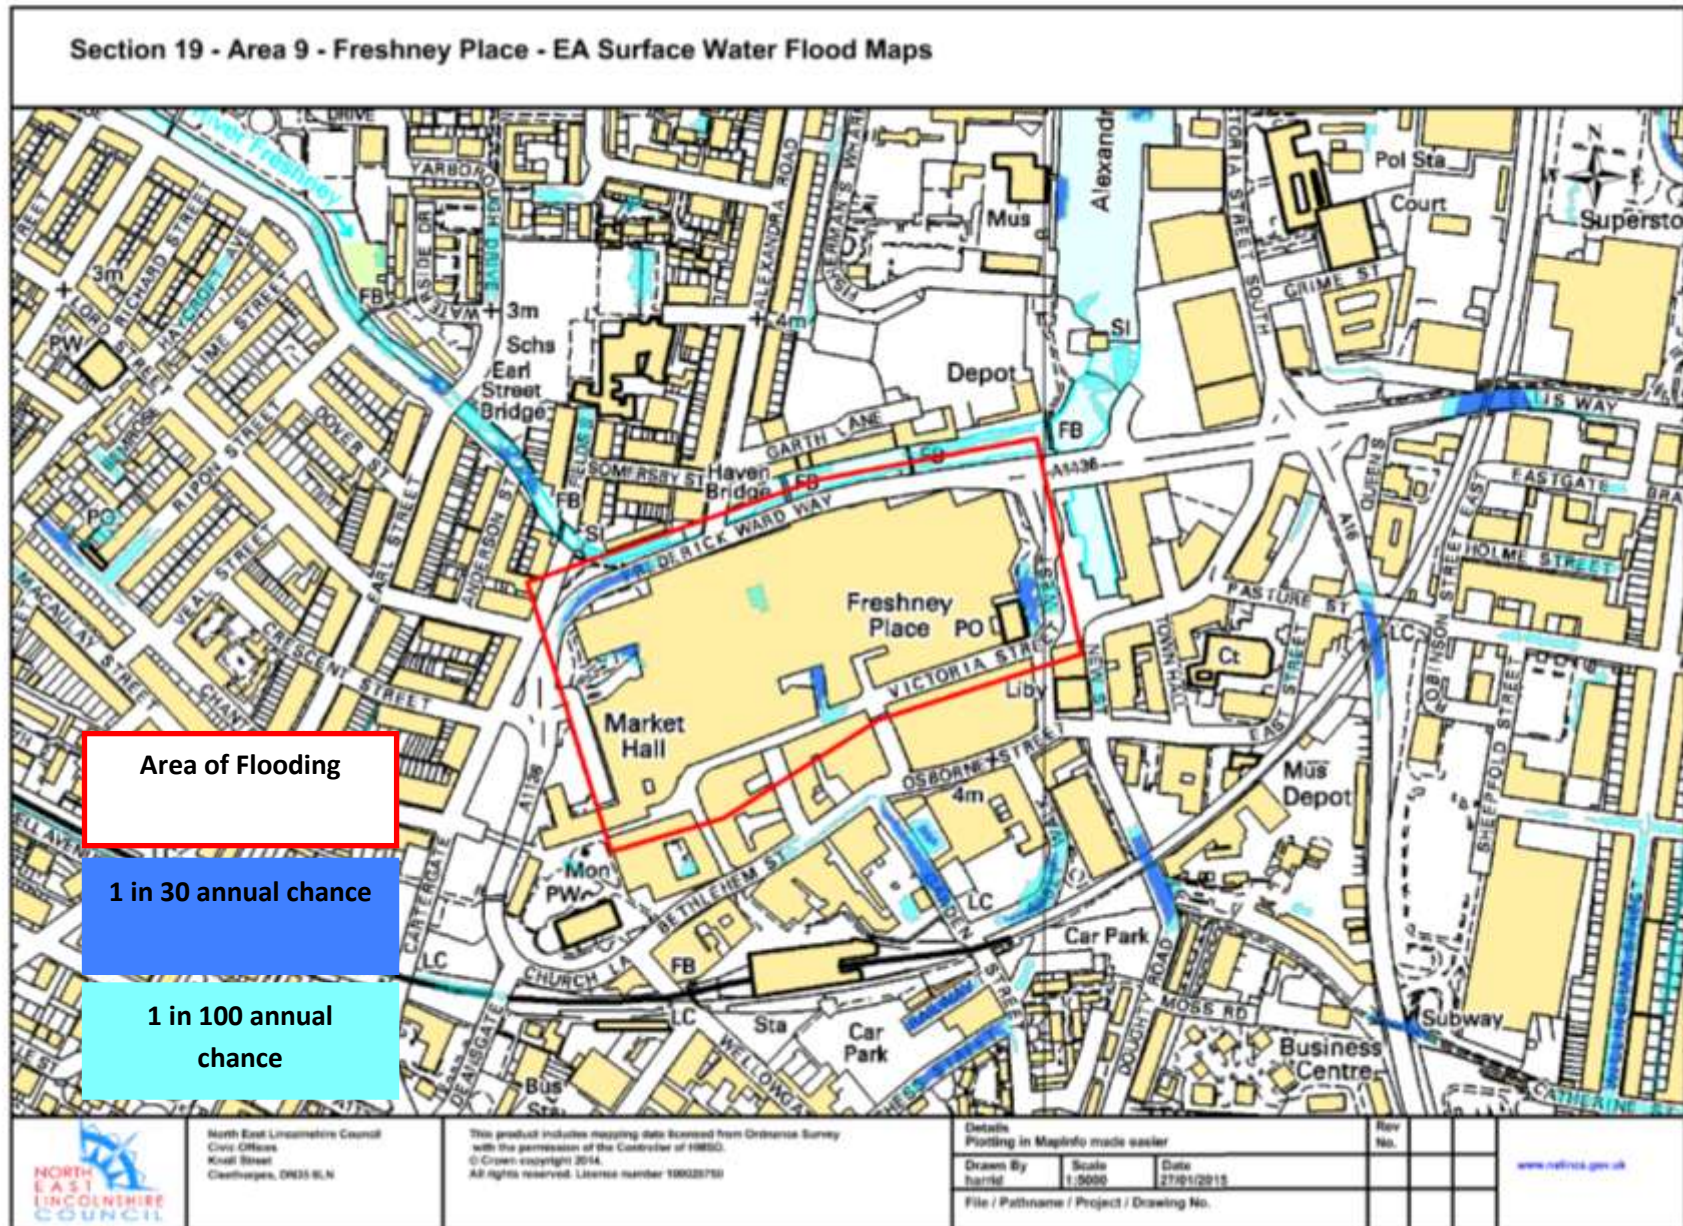
## Area 10 – Welholme Avenue

The extent of the flooding was noted by a Council Engineer in the early afternoon of 10<sup>th</sup> August about an hour after the rainfall event. Both affected properties had flood boards in place plus a pump was being used to level water levels. Without these measures internal flooding would have resulted.

- Residents reported surface water run off coming down Welholme Road, entering Welholme Avenue and adding to the flooding in the Close that was caused by the surcharging main sewer.
- The nearby Peoples Park was extensively flooded from the surcharging trunk sewer running in Welholme Road indicating widespread surcharging of the public sewer system in this location.
- Safe access was not available due to the design of the manhole in Welholme Avenue. This issue is to be passed to Anglian Water.
