Flood and Water Management Act 2010

Section 19 Flood Investigation Report

Immingham, North East Lincolnshire

28 June 2012

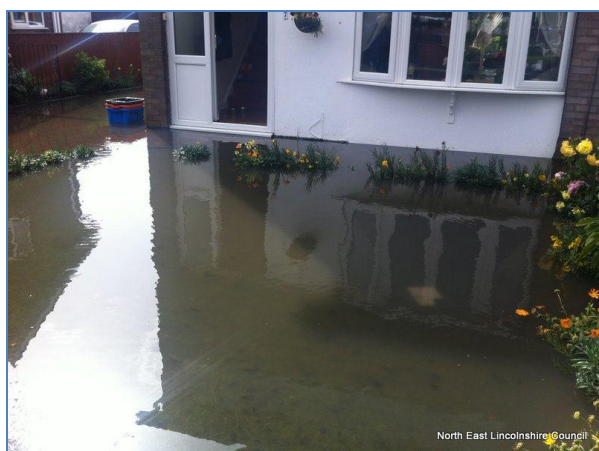
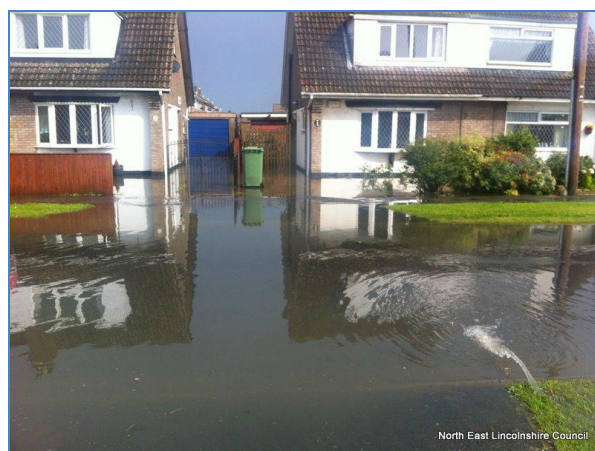
Woodlands Avenue/ Copse Close (3 Internal flooding – airbricks , 4 Severe Internal Flooding)

The main extent of the flooding was from the junction with Washdyke Lane to the west end of Woodlands Avenue. In total 7 properties were affected. The worst internal flooding (over the threshold) occurred at 2 properties in Woodlands Avenue. A week later the surface water public sewer that runs south from Woodlands Ave into Washdyke Lane was investigated and some jetting requirements were found.

Photos showing flooding at Woodlands Avenue

and opposite at Woodlands Avenue

Anglian Water were advised (13 July 2012) and surface water sewer jetting / CCTV recommended. A scheme to provide an overflow to the main sewer was completed by NELC during April 2013 with new gullies provided at the low spot within the street which outfalls to the ditch at the rear. NELC also cleaned out this ditch downstream to the NELDB watercourse and a section of undersized culvert is to be re-opened as a ditch. The riparian land owner will maintain responsibility for its maintenance in the future.

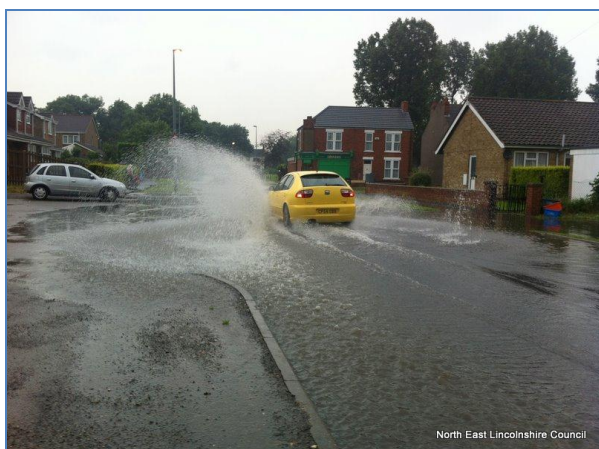
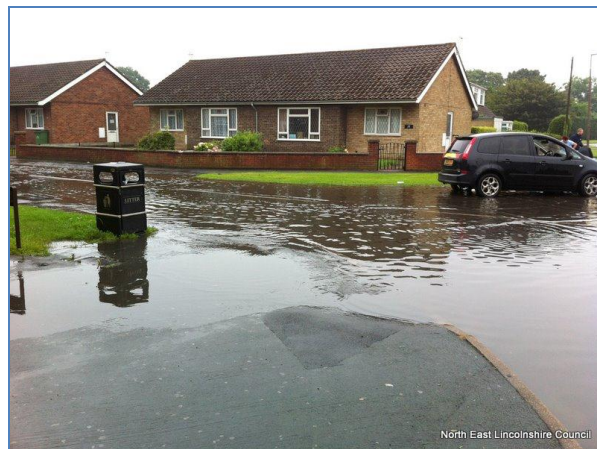
At the junction of Church Lane and Hollingsworth Close extensive highway flooding occurred. Although no reports of internal flooding were received, air bricks may have been breached.

Photos showing flooding at Church Lane / Hollingsworth Close junction

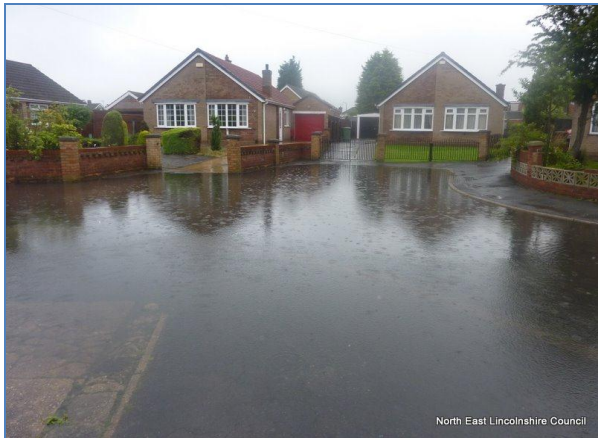
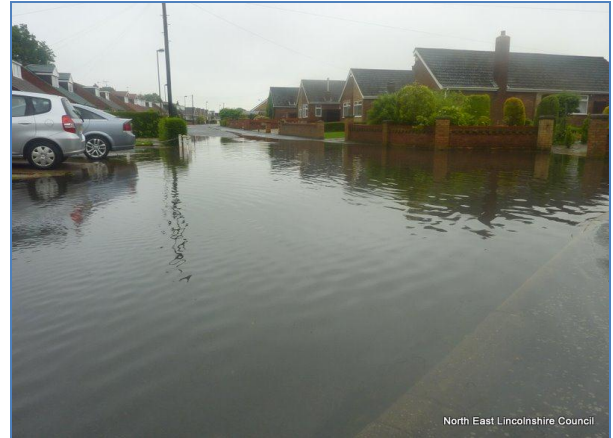
The surface water sewers of Sonja Crest connect to the same system as Robert Close and are affected by the same restriction. Once the Robert Close scheme is complete, this should alleviate the problems in Sonya Crest.

Photos showing flooding at Sonya Crest

The Robert Close scheme will have reduced flows in the existing system which will assist drainage in Sonja Crest.

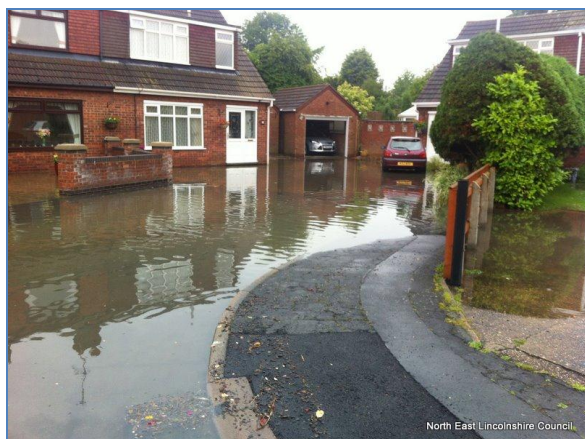
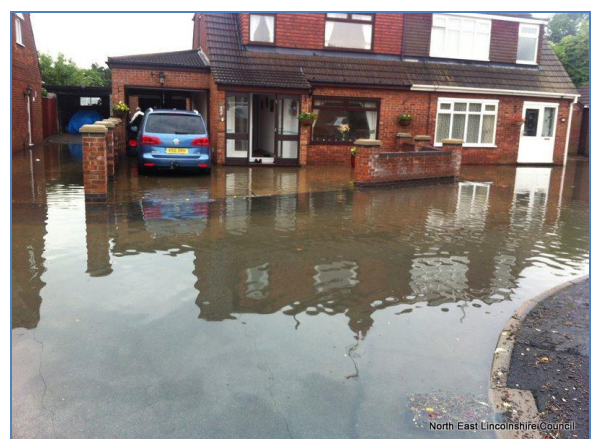
The cul-de-sac suffered extensive external flooding but there was no internal flooding. The cul-de-sac also suffered significant flooding in June 2007 with 4 properties reporting internal flooding. Anglian Water has acknowledged that the public sewer serving the Close is under capacity and confirmed that a scheme is currently being designed to increase capacity and remove the restriction to flows.

Photos showing flooding at Robert Close

Anglian Water has completed a scheme to increase the capacity of the sewers through to Pelham Road which should solve the issues in Robert Close.

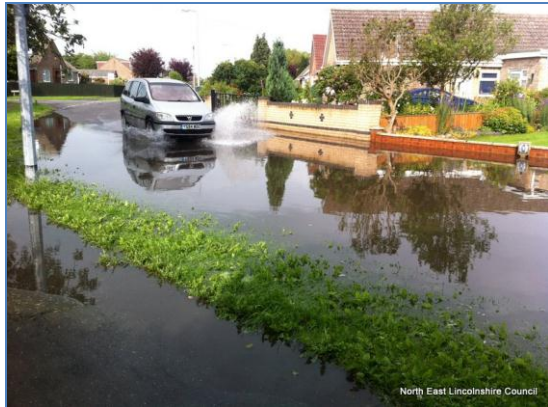
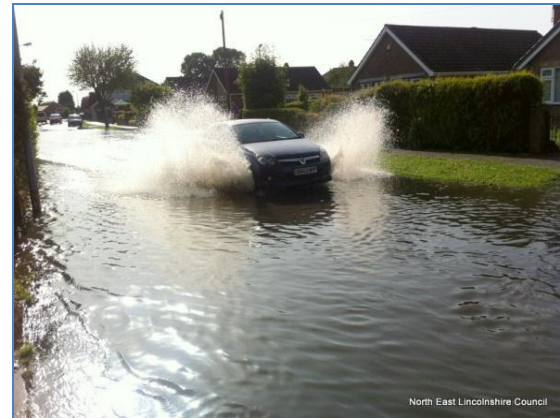
Flooding occurred at three main locations along Hume Brae; Mackenzie Place to James Way, and on the corner with Blossom Way. At these three locations the flooding was across the entire carriageway width and onto the footpaths. In some locations the flooding extended across the footpath into the front gardens. The electrical substation came close to being flooded but remained operational. The majority of the properties are set well back from the public highway and are generally higher. In June 2007 flood water flowed from Hume Brae through gardens and caused internal flooding at one property in Bowman Way, although the extent on this occasion was less severe. Investigations found that highway gullies at the upstream end of the system were surcharging out onto the public highway.

Investigations one week later found that the surface water sewers towards the upstream end (near James Way) were full of water. In the mid part of the system (Clarence Close) heavy silt and root ingress was found but at the manhole adjacent to the southern boundary of the Blossom Way playing field the sewer was clear.

Photos showing flooding at Hume Brae

The highway gullies have been repaired on Hume Brae.

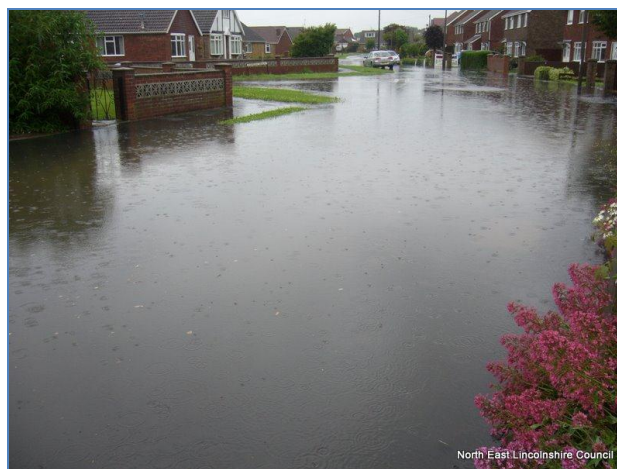
A report was received on Friday 29 June, from a property in Highland Tarn about flooding the previous day. A site meeting was held with the resident. He explained that it is a persistent problem due to his garden being the low spot, and he often gets run off from the road going down his driveway. His external garage had flooded on 28 June and also previously in the June 2007 floods. He had photos of the event which were provided.

A level survey was carried out to see if the run off from the highway issue could be resolved. The survey showed no significant level problem, only slight low spots, and whilst the survey was being carried out it was raining and the water was getting away. The site is to be re-checked during heavy rainfall to see the extent of the problem with surface water run off from the highway.

Photos showing flooding at Highland Tarn / Hamish Walk junction

This system outfalls to an NELDB ditch at the rear of Meakin Court. The outfall was restricted by debris which had become trapped against the screen. The screen has been cleared and AWS have cut off the lower portion of the screen to allow debris through. This will also be inspected monthly and access steps to the screen have also been erected.

Anglian Water were advised (13 July 2012) and surface water sewer jetting was recommended.

At the rear of 13 – 27 Highland Tarn, root ingress problems in the surface water public sewer were found by the Council drainage team. AWS carried out some investigatory works and root cutting and they have exposed two buried manholes.

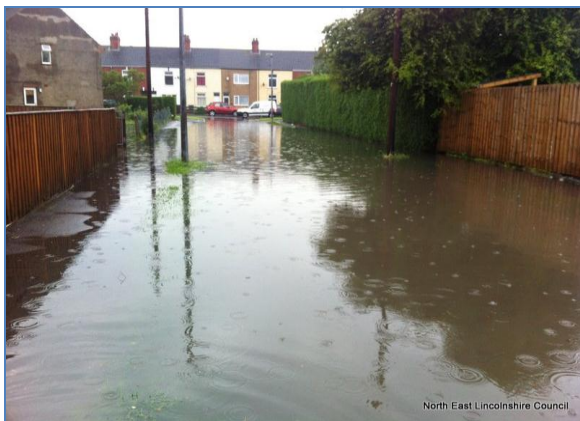
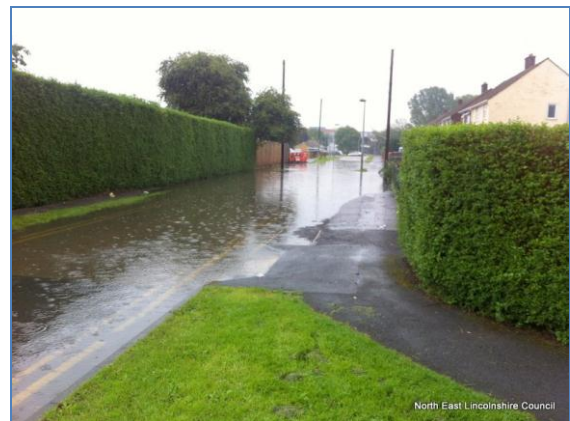
Flooding across the entire carriageway and both footpaths, although no internal flooding occurred. A subsequent investigation found that the public sewer at the head of the system in Craik Hill Avenue was partially blocked with bricks and part of a manhole cover. The manhole cover had recently been replaced. There was also siltation build ups in the public sewer.

Photos showing flooding at Craik Hill Avenue

Anglian Water have been advised to clean the manhole out and carry out sewer jetting as debris is likely to have built up in the pipework.

A broken cover and debris was found inside an AWS manhole, causing a blockage. This has now been cleared.
