# **Written Record of Determination CONTAMINATED LAND**

Landfill 4  
Land off Moody Lane, Great Coates, Grimsby  
DN31 2SS. United Kingdom

Site reference: NELC/CL5a/Landfill 4

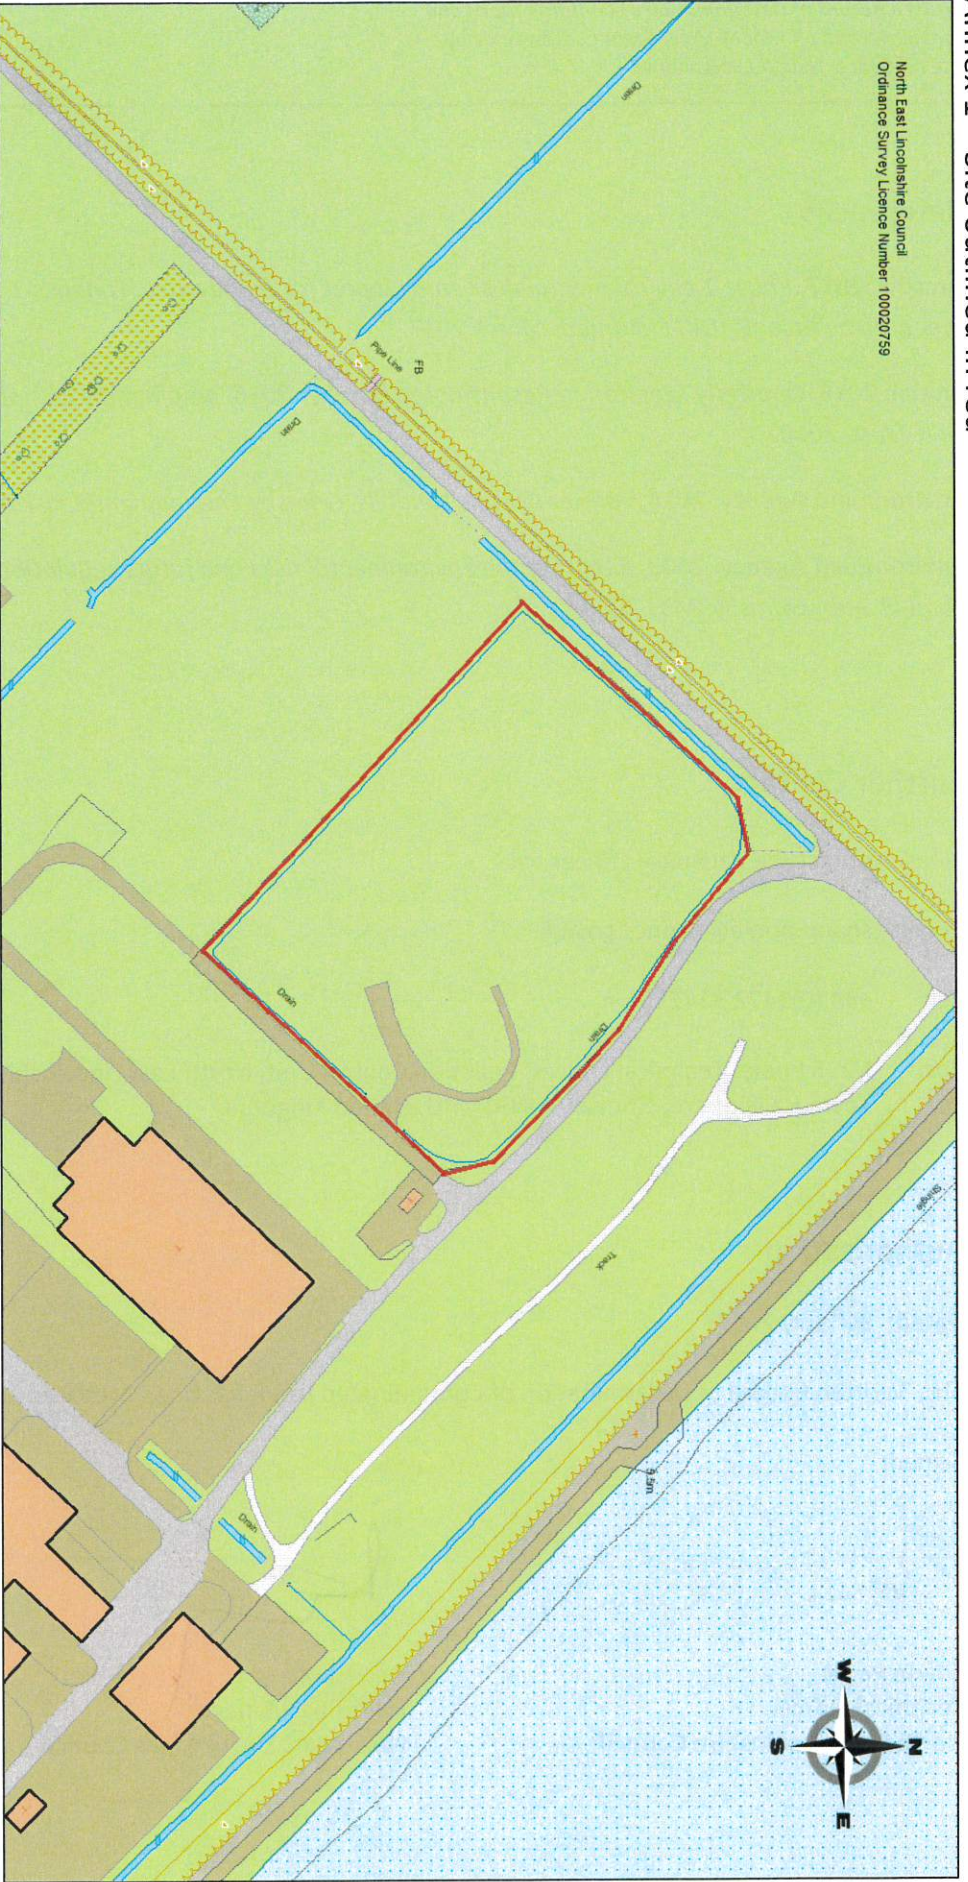
Annex 1 – Site outlined in red

***A site plan is presented in Annex 1***

This information forms the basis for the Authority determining the land identified in Annex 1 as contaminated land, as defined in Section 78A(2) of Part IIA of the Environmental Protection Act 1990.

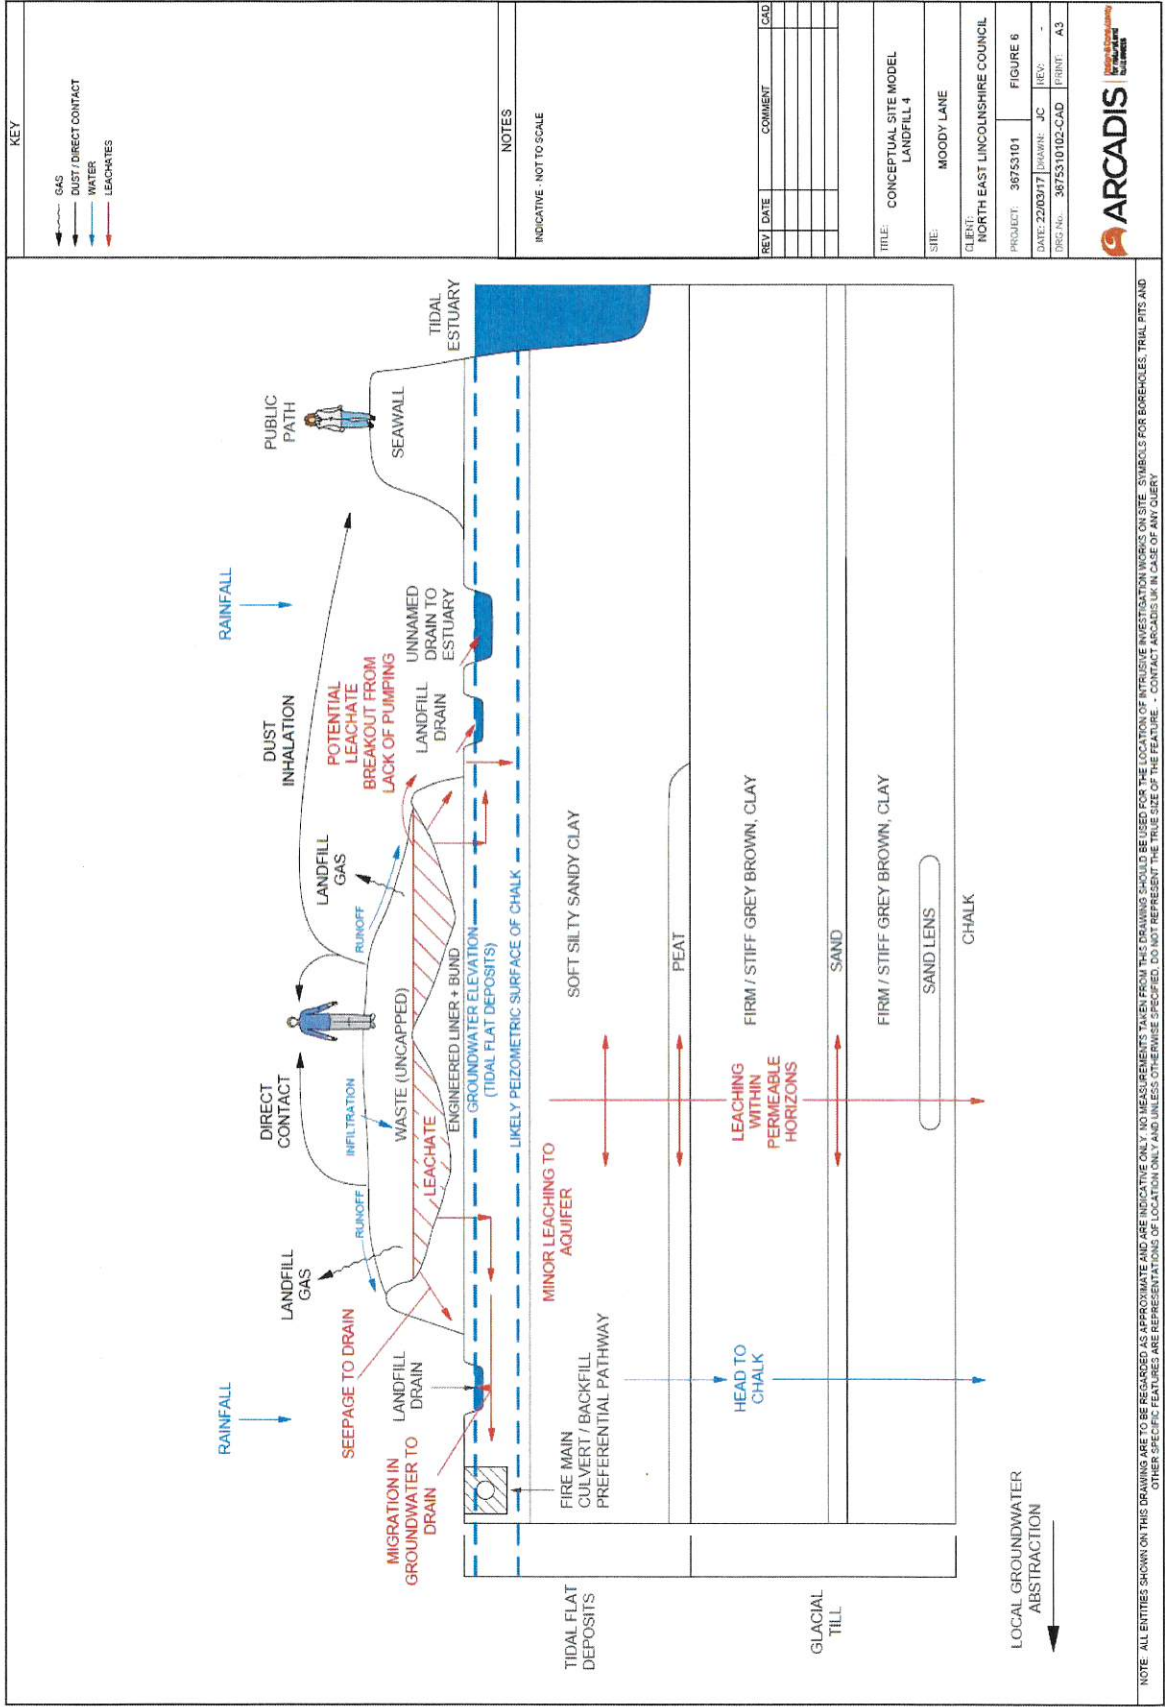
## Annex 2 – Pictorial representation of Conceptual Site Model

<b>Significant Contaminant Linkage</b>	<b>CONTAMINANT:</b>	Landfill leachate containing known elevated concentrations of sodium thiocyanate, ammoniacal nitrogen and chloride
	<b>PATHWAYS:</b>	Overtopping of landfill berm (clay mound) forming the south-western perimeter of landfill 4, into surface water land drains which flow towards Mawmbridge Drain
	<b>RECEPTOR:</b>	<p>Mawmbridge Drain (Controlled Waters)</p> <p><i>Controlled waters include relevant territorial waters, coastal, inland freshwaters (including lakes and ponds) and groundwaters.</i></p>

**An illustrated site conceptual model is presented in Annex 2**

The Authority considers that the factual content of (Arcadis, 2017) and the conceptual model presented in Annex 2 constitute a scientific and technical assessment of the available evidence.
