# VERIFICATION REQUIREMENTS FOR COVER SYSTEMS

Technical Guidance for  
Developers,  
Landowners and  
Consultants

**Yorkshire and Lincolnshire  
Pollution Advisory Group**

**Version 3.3 – October 2016**

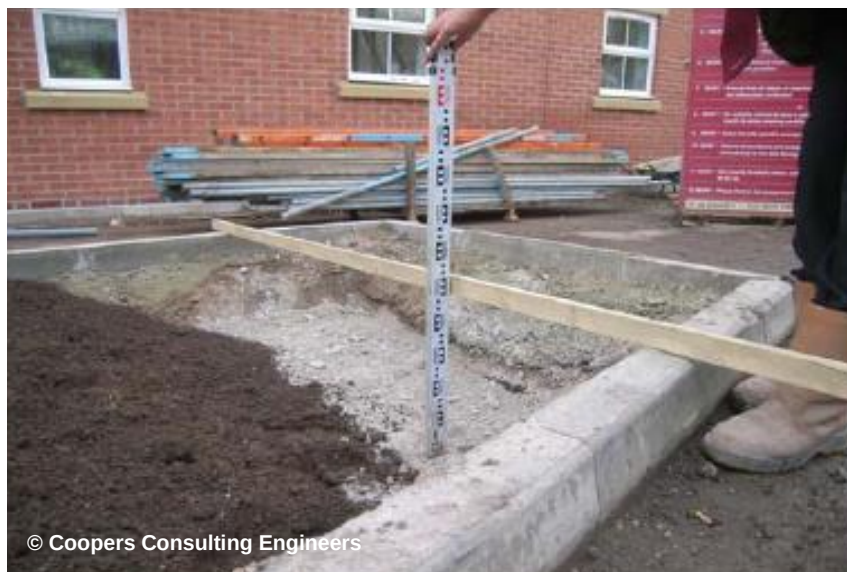
Photograph 1: Depth check of inert cover within area of public open space. Physical break layer and topsoil visible.

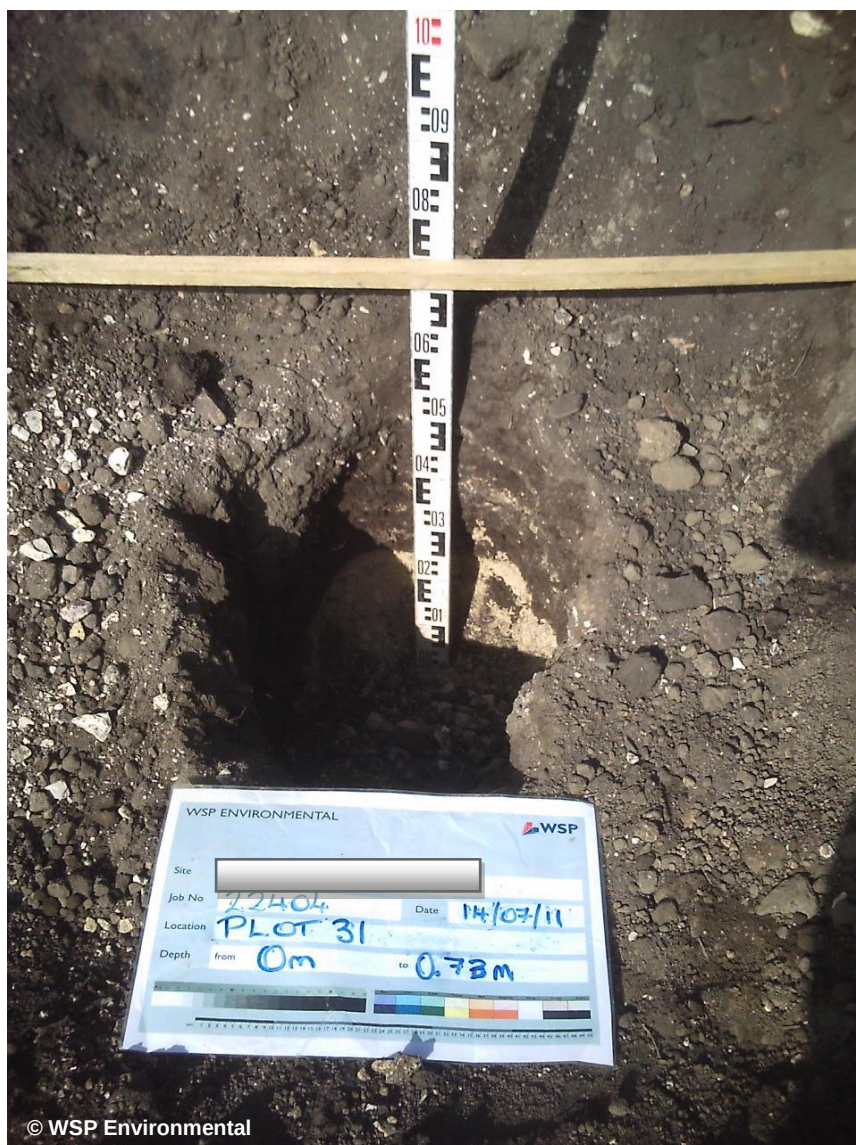
Photograph 2: Depth check of inert cover with Site & Location Information Board.

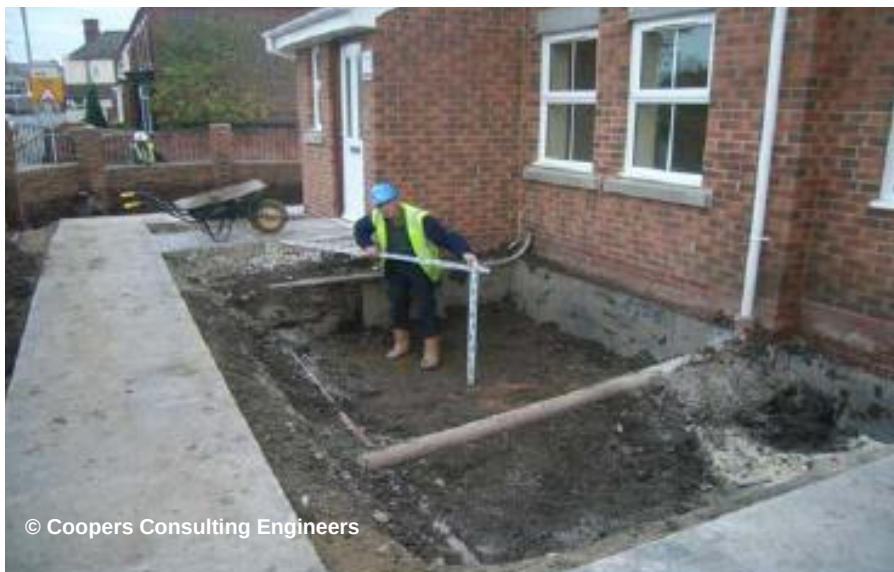
Photographs 3 & 4:  
Depth check of inert  
cover within areas of  
front gardens.

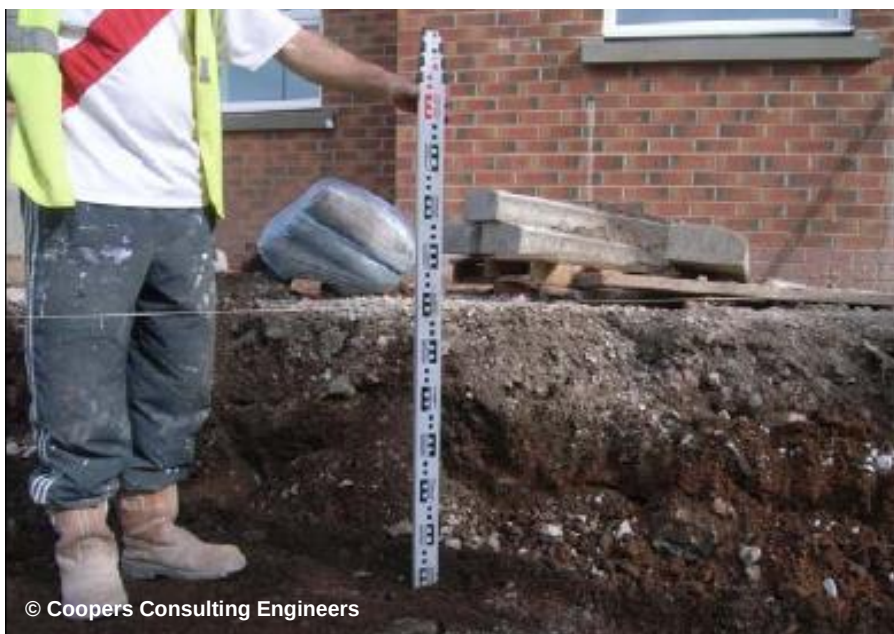
Photographs 5 and 6: Depth check of inert cover within rear gardens. Taut string line spans across excavation.

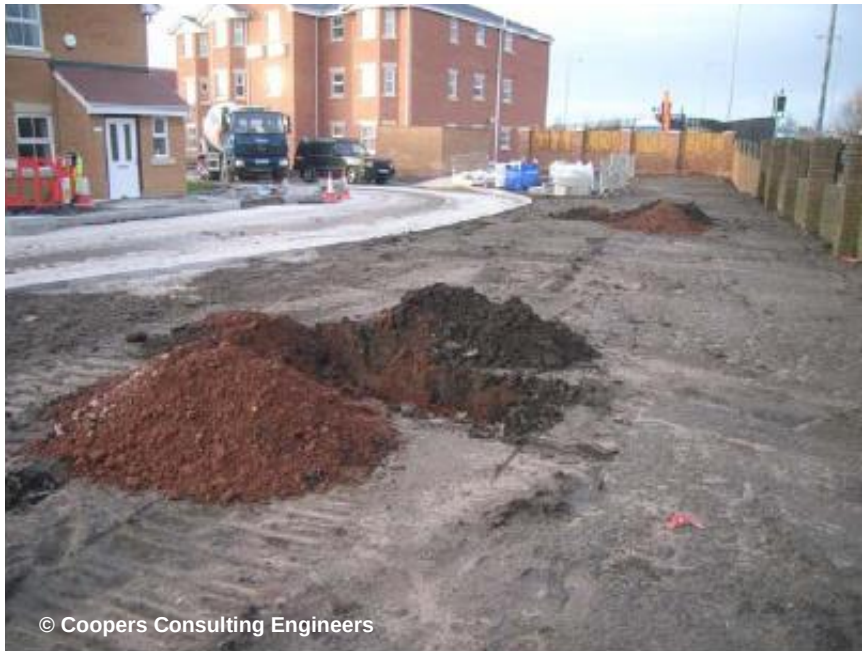
Photograph 7 shows the spatial location of the verification pit.

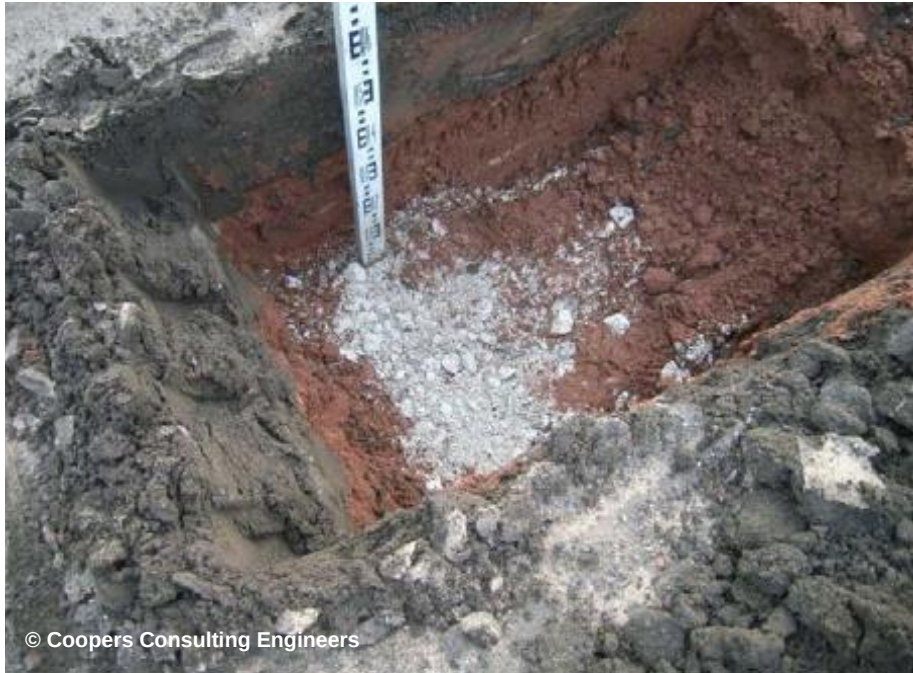
Photograph 8:  
Excavation within public open space and verification pit showing the presence of a remediation break layer at the base, a crushed sandstone inert fill overlain by topsoil.

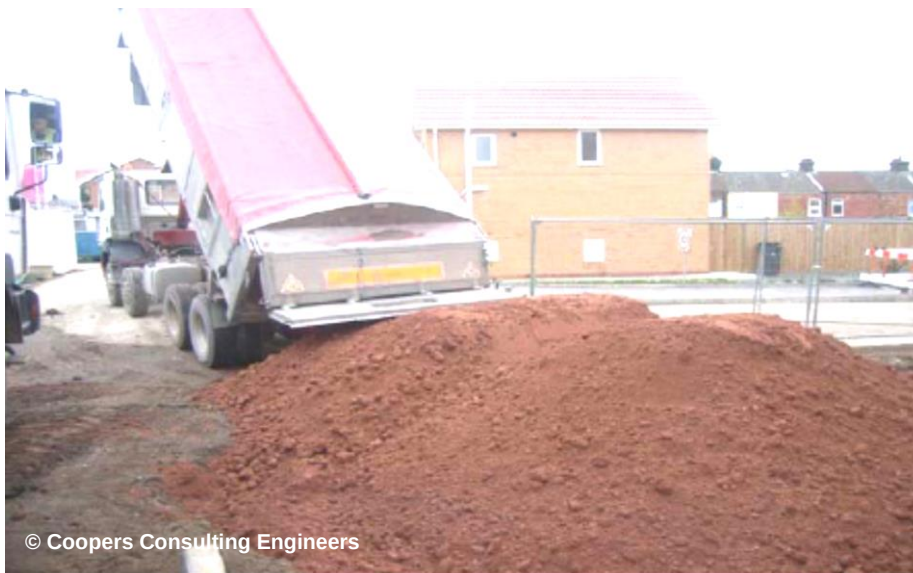
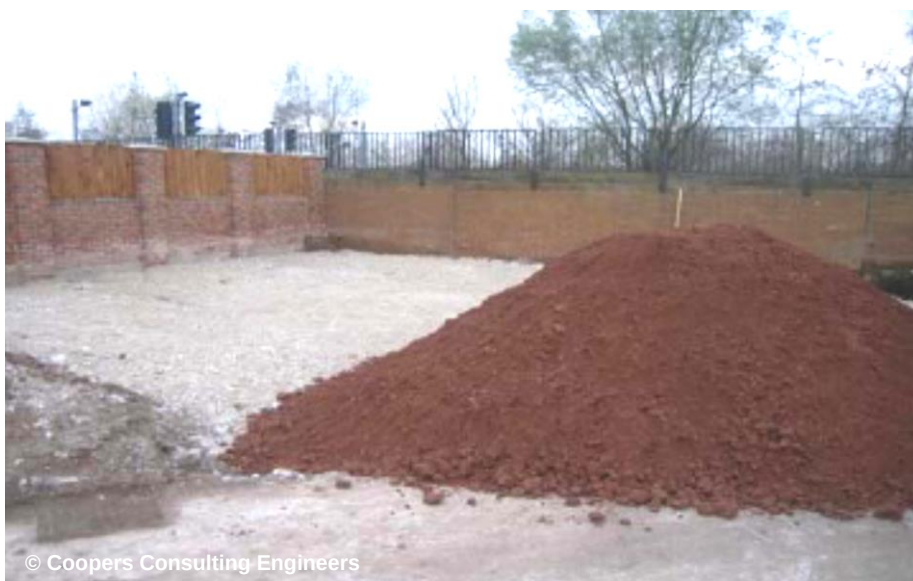
Photographs 9 and 10: Inert crushed sandstone being delivered with remediation break layer visible in Photograph 10. The spatial area of the remediation can be observed from these photographs (old terrace housing in Photograph 9 and traffic lights in photograph 10).

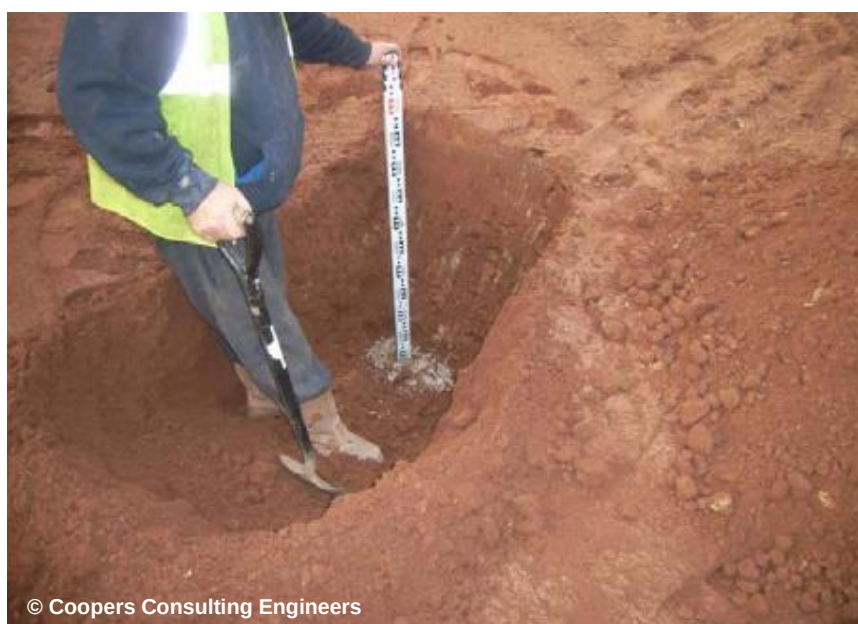
Photographs 11 and 12 show the remediation of the rear garden, with a significant depth (1.0m) of inert cover. Remediation break layer visible at the base of the excavation. Photograph 11 has been stitched to form a panoramic photograph and
