LISTED BUILDING ENFORCEMENT NOTICE

Land at 1-3 Bethlehem Street, Grimsby, North East Lincolnshire, DN31 1JN, (“the building”) shown edged in red on the attached plan.

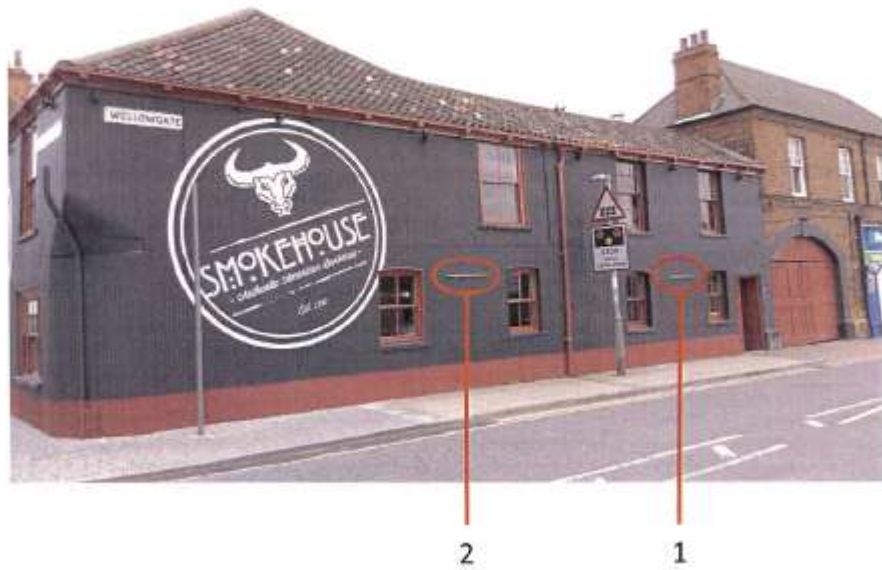
- 3.5 The addition of 2 exterior painted SMOKEHOUSE advertisements (see Photos 17 and 18).
- 3.6 The addition of 4 hanging apparatus which are used for the display of advertisements (see Photos 3 and 4).

Photo 3 – Showing copper hanging rails 1 & 2 on Wellowgate

5.2 Remove 4 external copper hanging rails and fixings which are used to display advertisements (see Photo 3 and Photo 4).

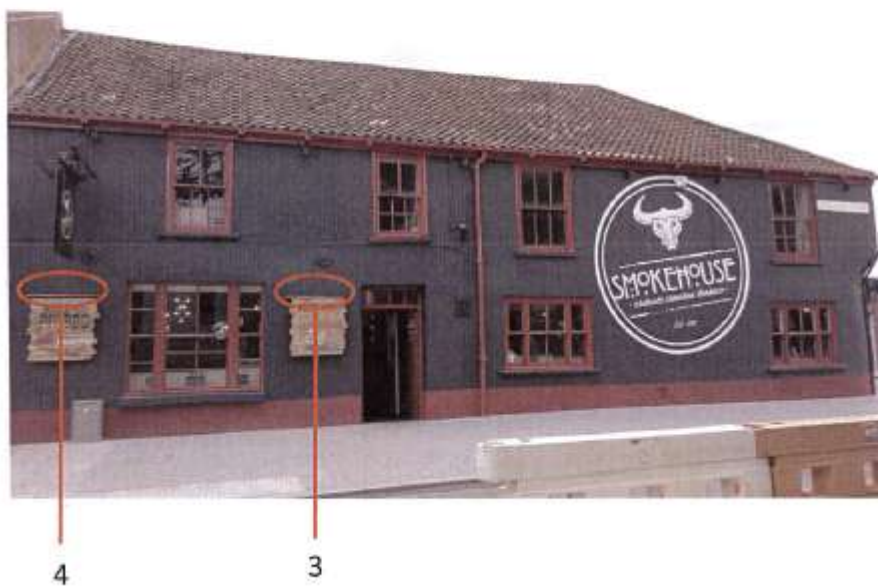
Photo 4 – Showing cooper hanging rails 3 and 4 on Bethlehem Street

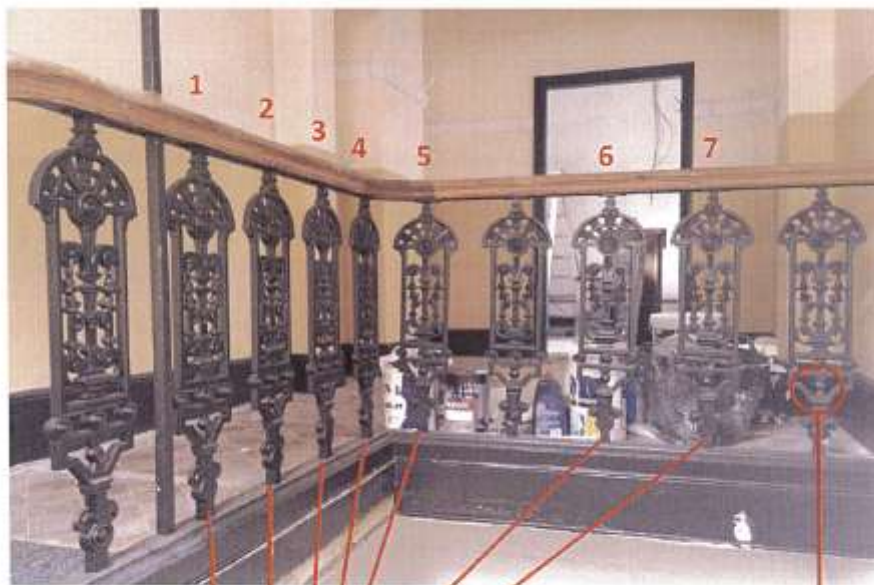
replaced incorrectly (see Photo 10) and 1 being missing (see Photo 8).

Photo10 – Showing incorrect facing incl
incorrect facing spindles

In Incorrect facing spindles – mould
facing the footplate.

Correct facing
spindle – mould
facing away from
the footplate.

- 5.11 Carefully remove the 7 spindles which are orientated incorrectly (see Photo 10) making sure the banister and footplate is not damaged. Replace these spindles so that they match the remaining spindles (see Photo 9) in orientation.
