Item 2

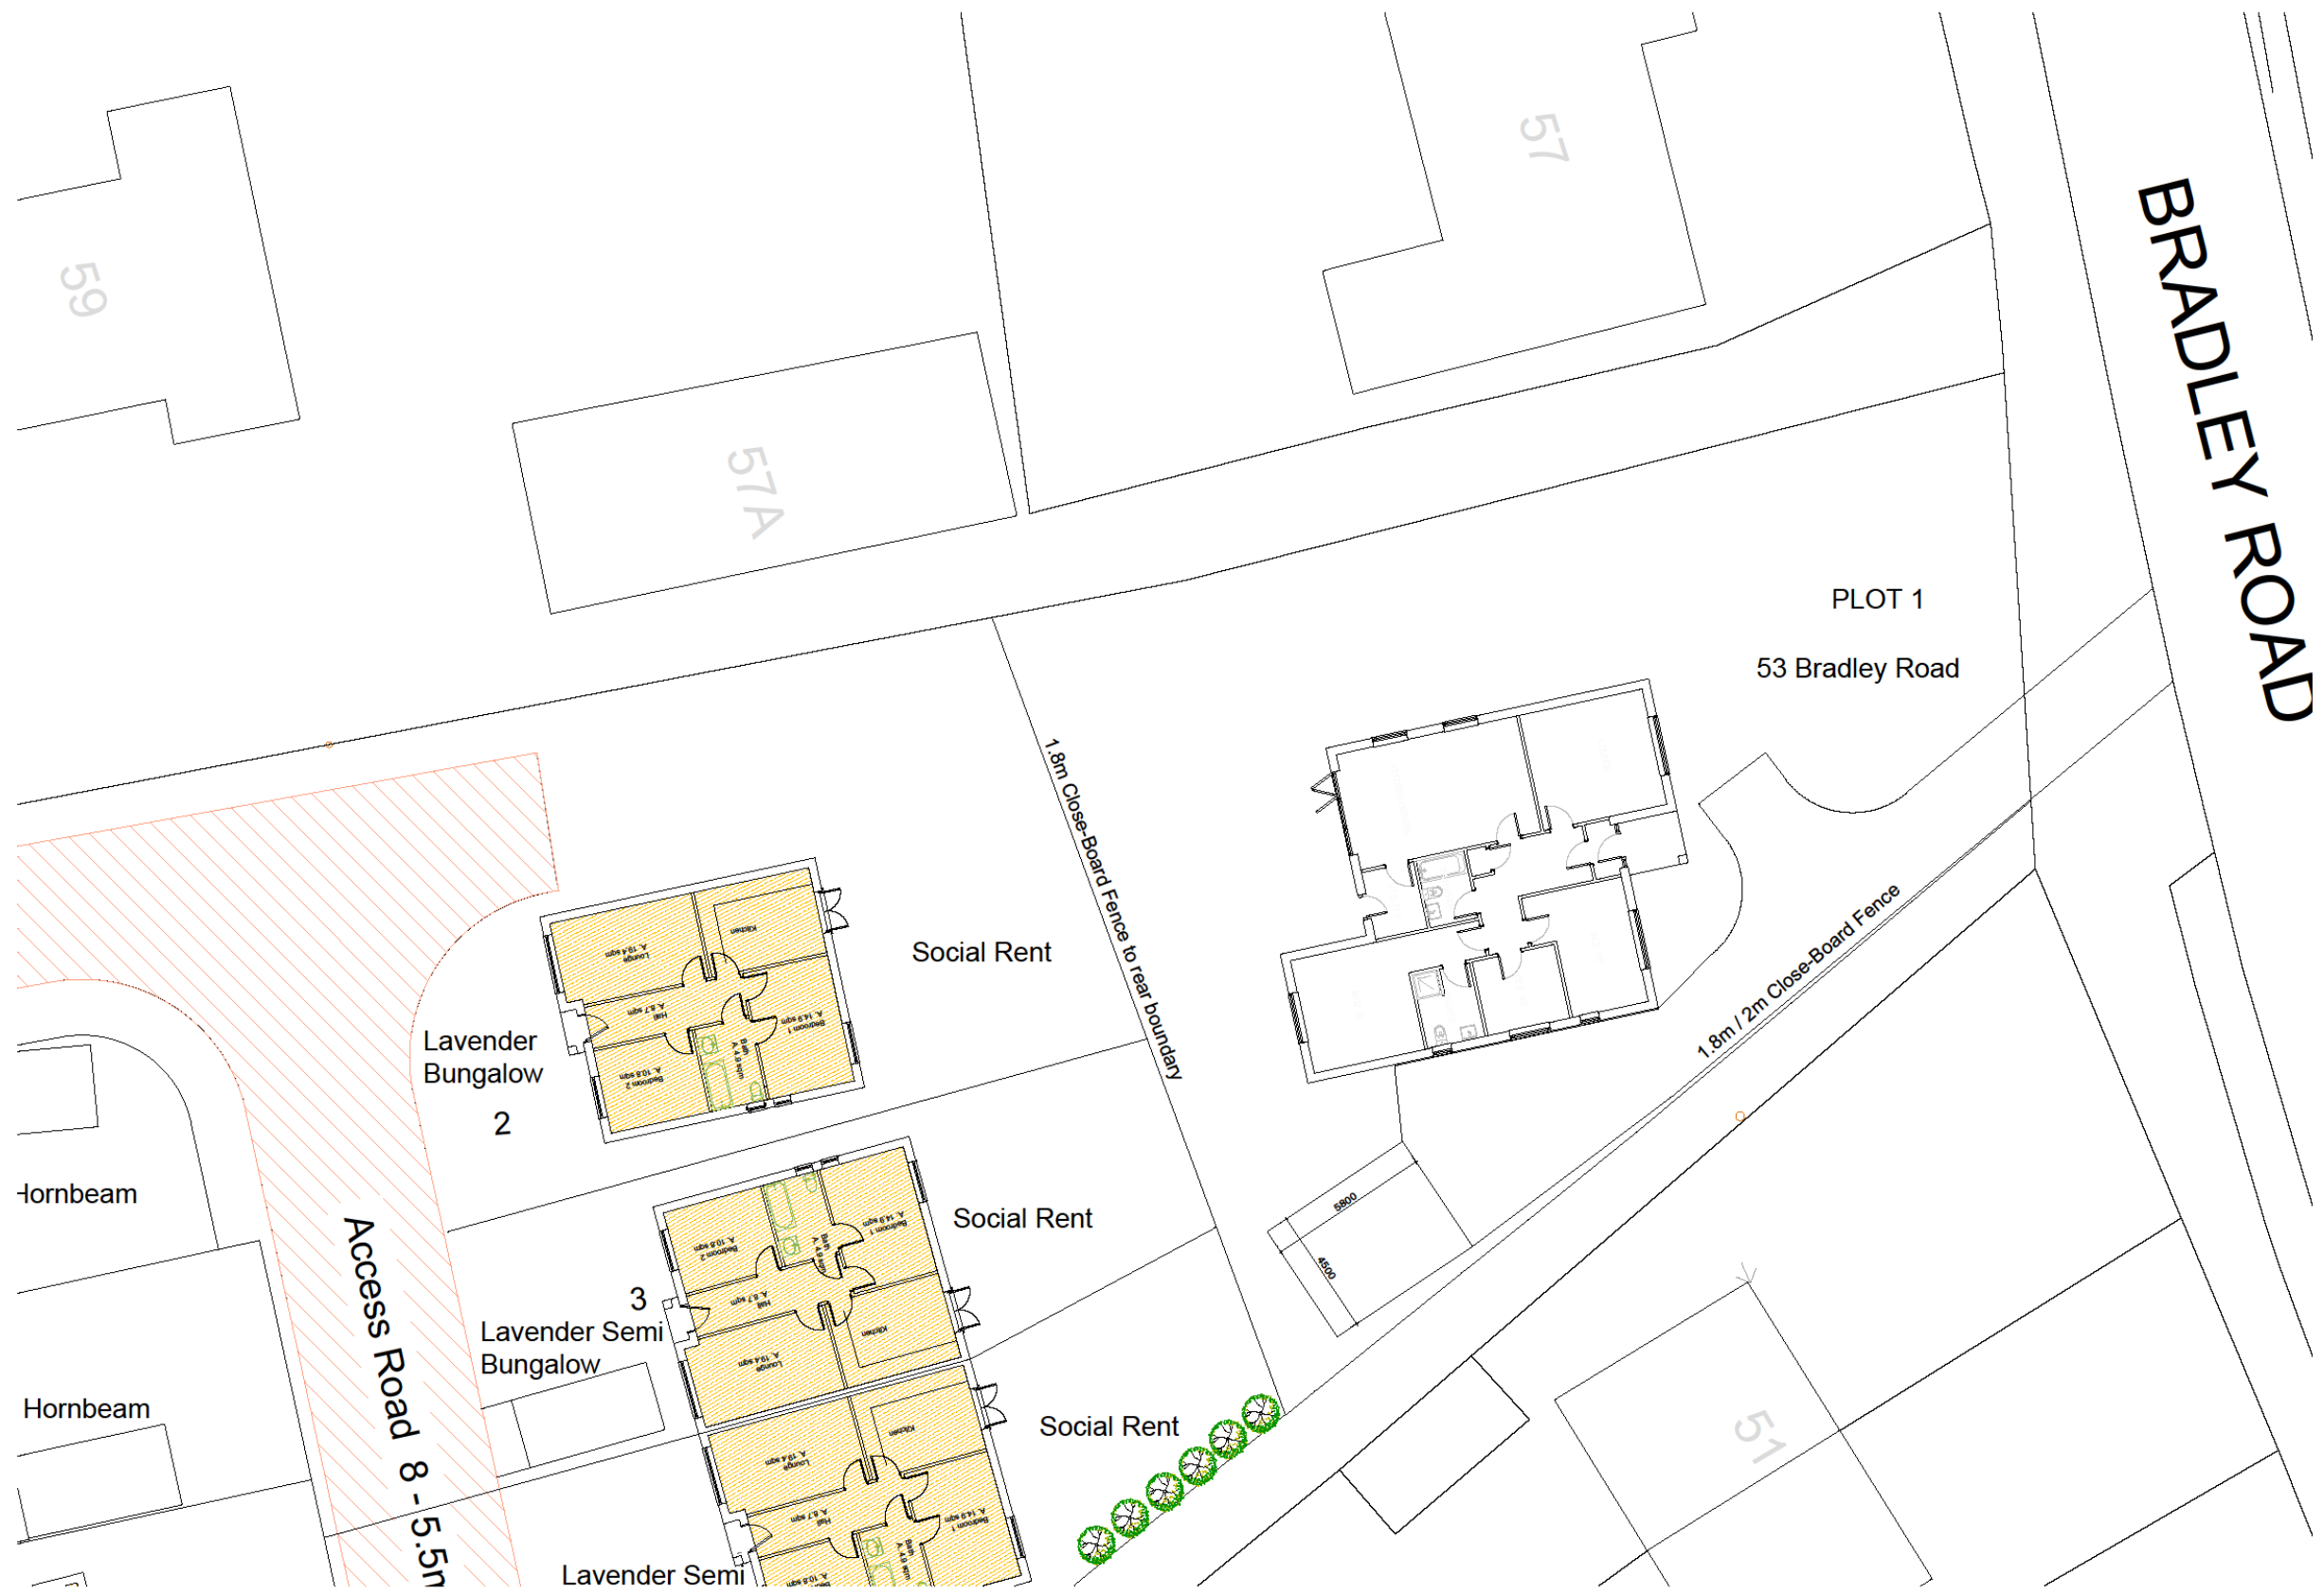
FIG. 4 - Plot 1 – 53 Bradley Road – Site Plan as per OS mapping data.

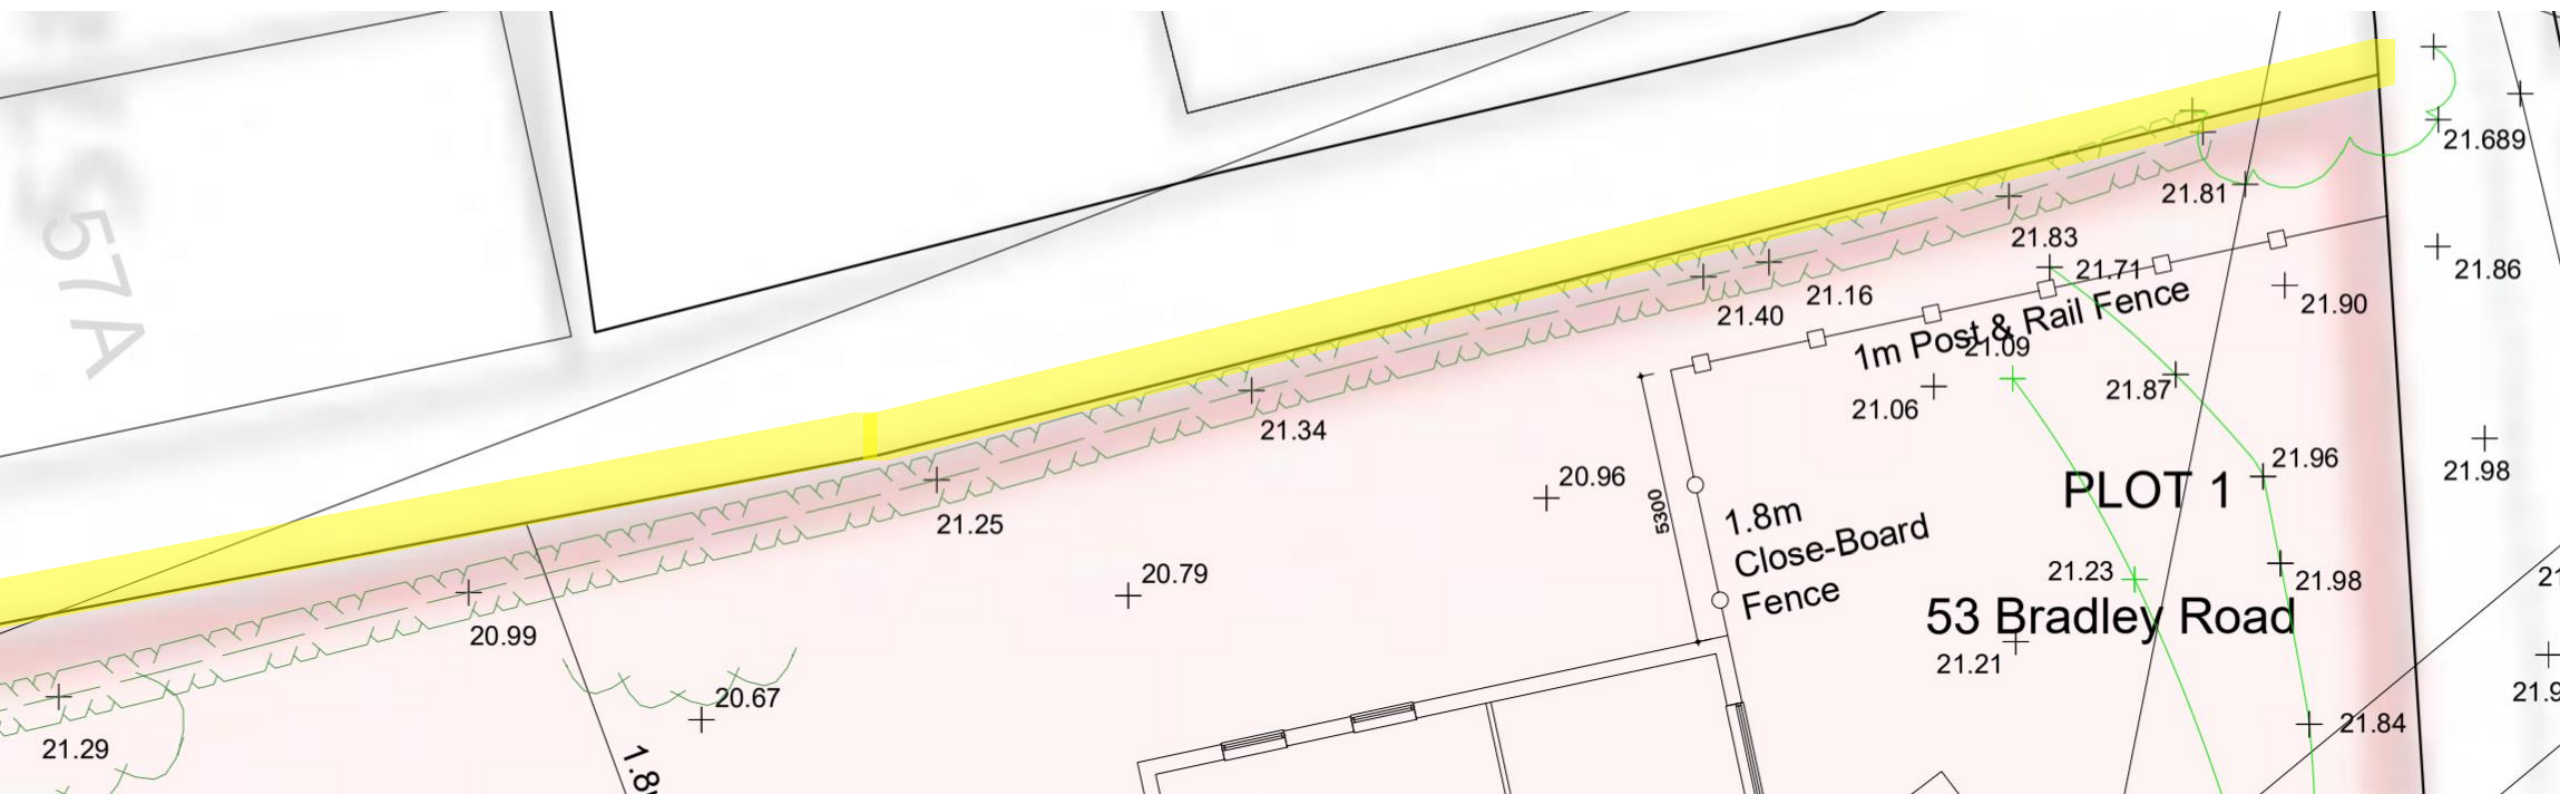
FIG. 7 - Enlarged View - showing the existing hedge (2016 survey) and the Title Deed red-line boundary. The yellow highlighted OS plan line dictates the boundary, note that the surveyed hedge sits within the limits of Plot 1's boundary. Also, note that the hedge has grown/spread considerably since the survey was undertaken.

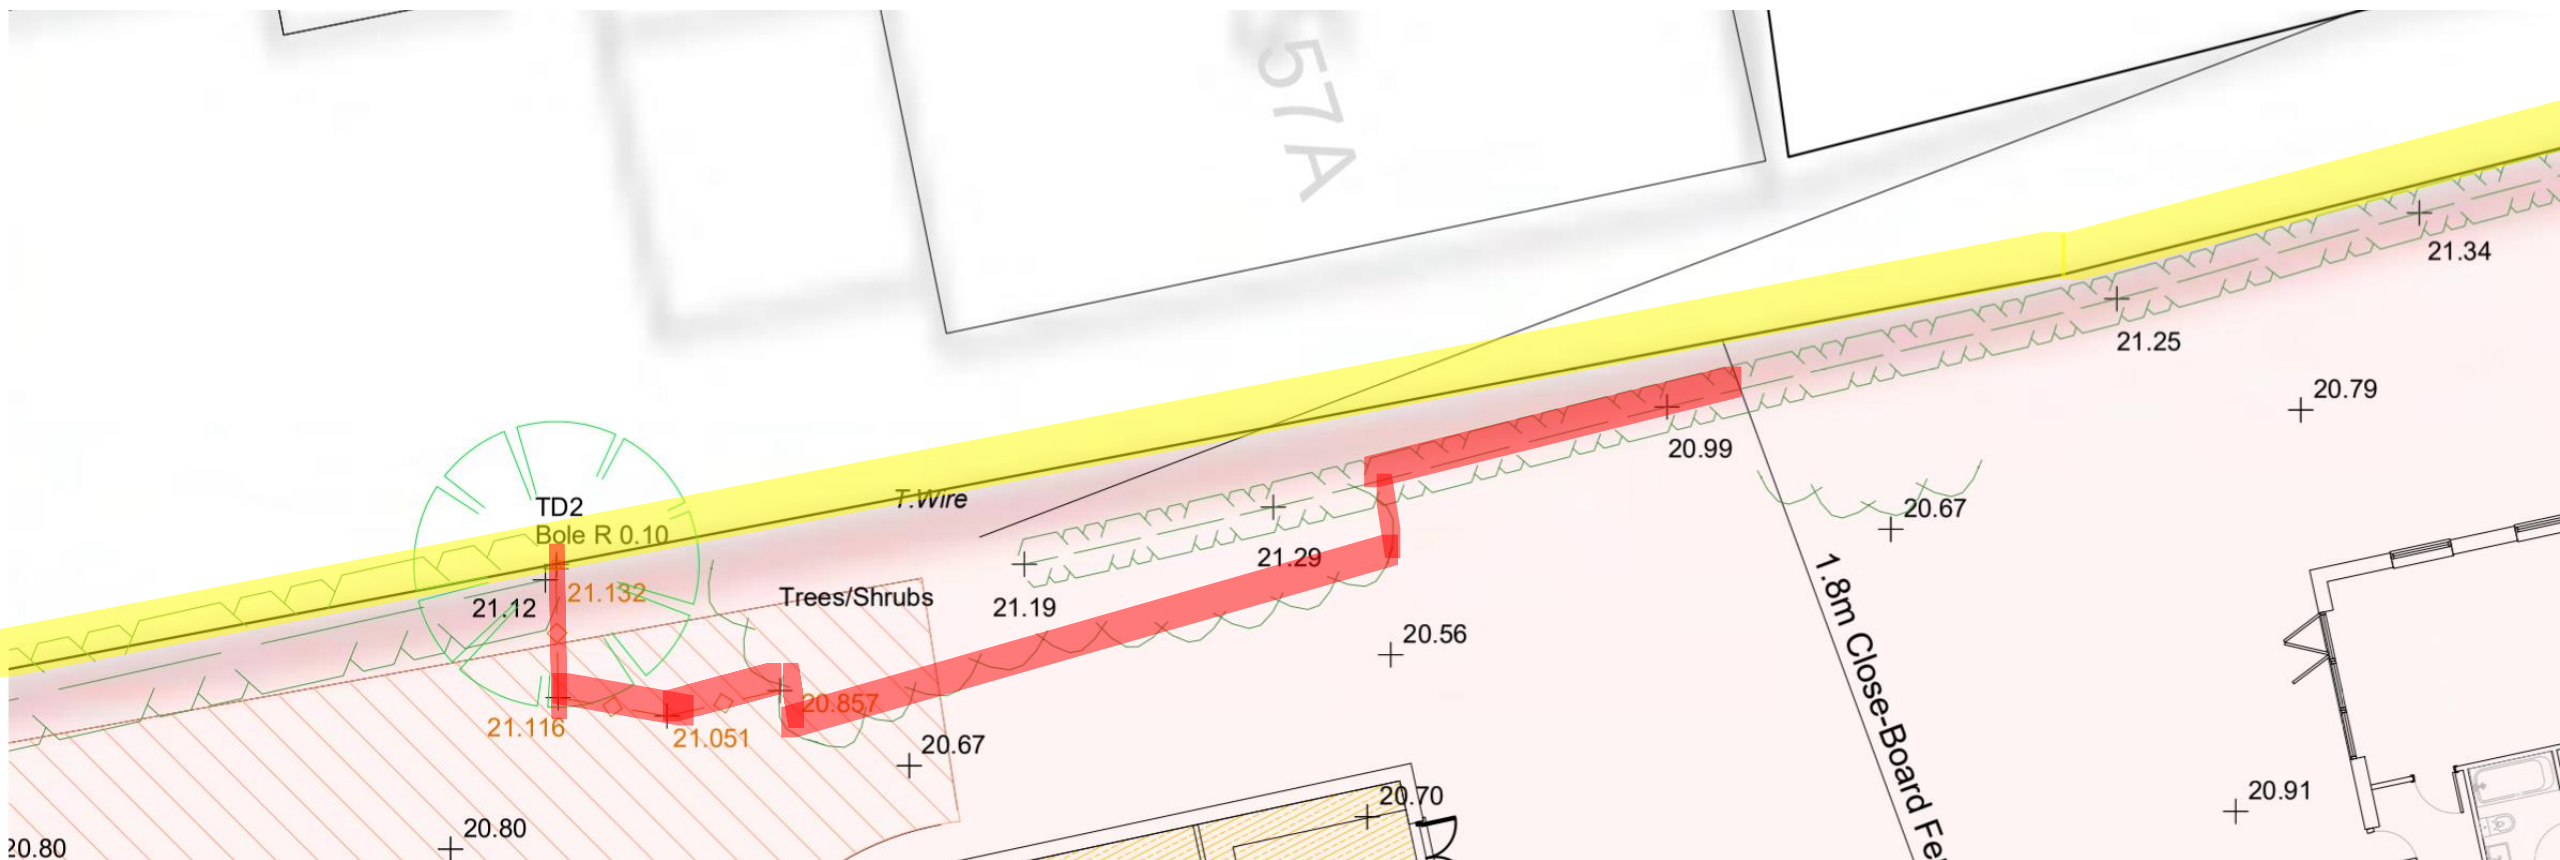
FIG. 8 - Enlarged View - showing encroachment onto Snape Homes site by neighbours at 57A and 59.
