# Cast Iron Maintenance Guide

## Cleethorpes – North East Lincolnshire

A Maintenance Guide for Building Owners with Victorian Cast Iron Balconies and Structures within The Central Cleethorpes Seafront Conservation Area.

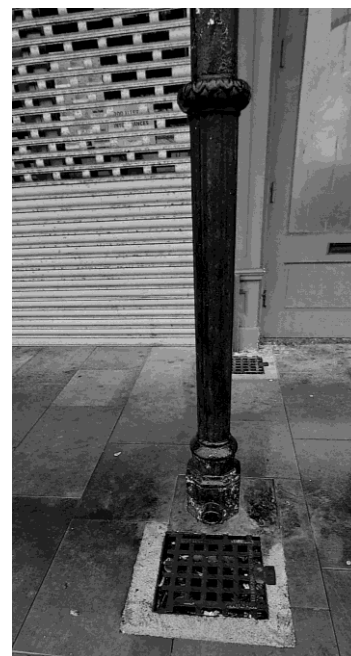
4. Depending on the design of cast iron, some of the front cast iron columns of the balcony act as rainwater outlets (downpipes), taking water from the decking above, see image as an example. Use the same approach as item 3 above to clear any blockages.

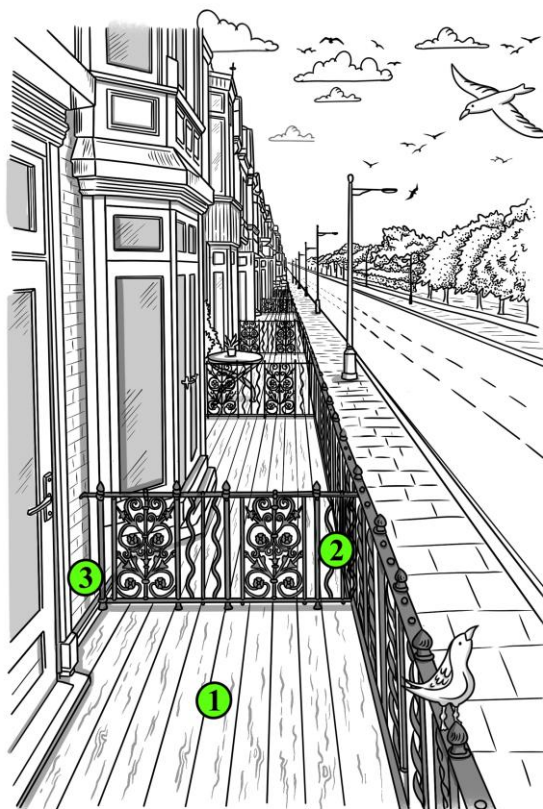
The decking structure of the balconies is mainly made up of following components:

1. Timber decking boards with waterproof membrane beneath which prevent water going through to the pavement below. This material can be like that used on flat roofs. If the balconies have not recently been restored, then materials could differ, and there could be a single concrete type material finish, or a membrane with no timber decking over.
2. Cast Iron panels which form the safety barrier, which are fixed through the decking material.
3. Rainwater outlet could be present see section 2.1 (3) above.

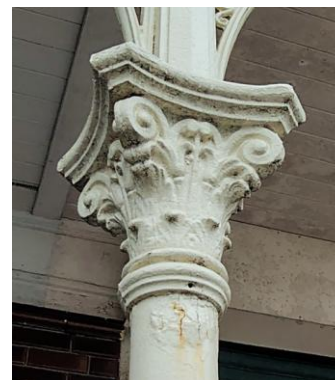
Paint failure is often the first sign that moisture is reaching the iron beneath. Rust spots or 'gingering' is caused by a break in the surface of the paint, exposing the metal to the marine environment, leading to corrosion. Early detection and remedial action are key to protecting the structures and saving money. They do not indicate a failure of the material but left untreated they could become a structural issue in the future.

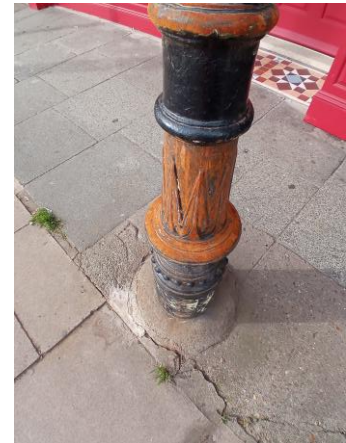
This recommended procedure is for preparing small areas of rust only. When carrying out maintenance, full scale stripping of paint in situ is not recommended due to the marine environment as the cast iron will react to the salt and rust very quickly. This example shows what can happen when the whole of the surface coating is taken back to bare metal.

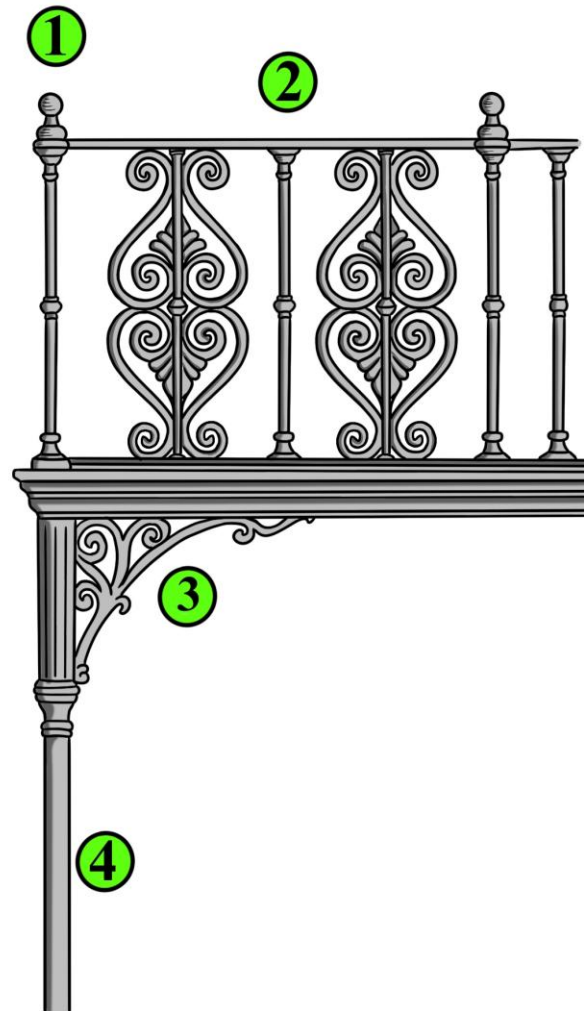
## Example of a cast iron framework

1. Post
2. Panel
3. Spandrel Bracket
4. Column

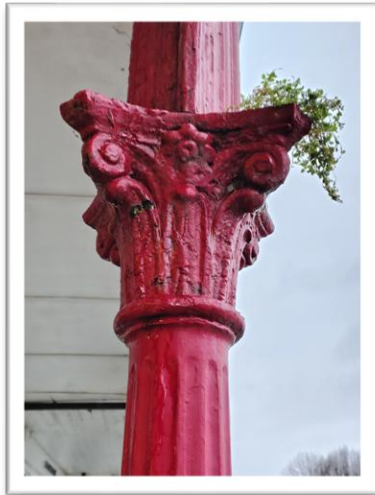
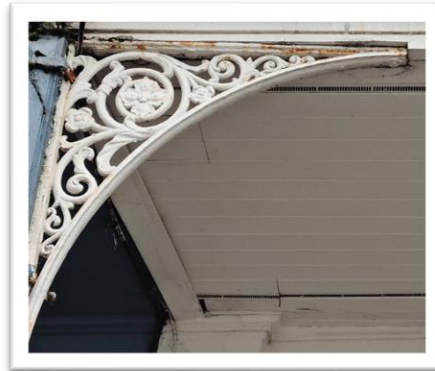
Examples of rust spotting and vegetation growth

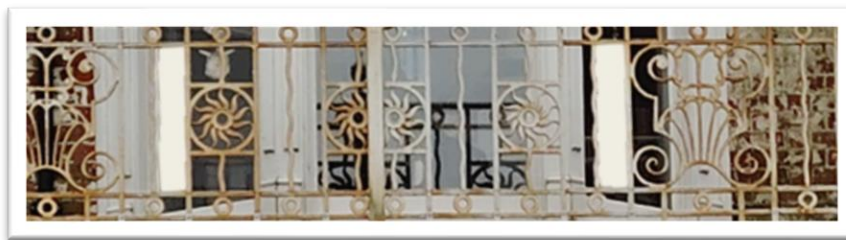
Example of cast iron which has been stripped back to the metal and not had the correct propriety coatings applied for a marine environment

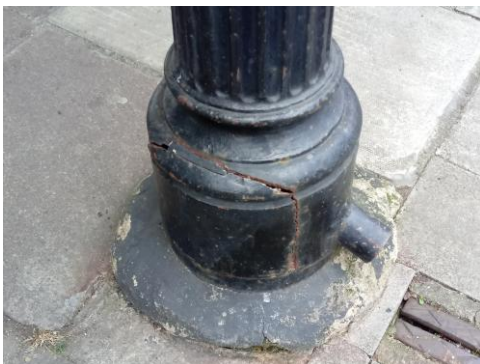
Example of fractured cast iron which required specialists to repair
