**SECTION 38 (1) PLANNING (LISTED BUILDINGS AND CONSERVATION AREAS) ACT 1990**

**LISTED BUILDING ENFORCEMENT NOTICE**

Land at 1-3 Bethlehem Street, Grimsby, North East Lincolnshire, DN31 1JN, (“the building”) shown edged in red on the attached plan.

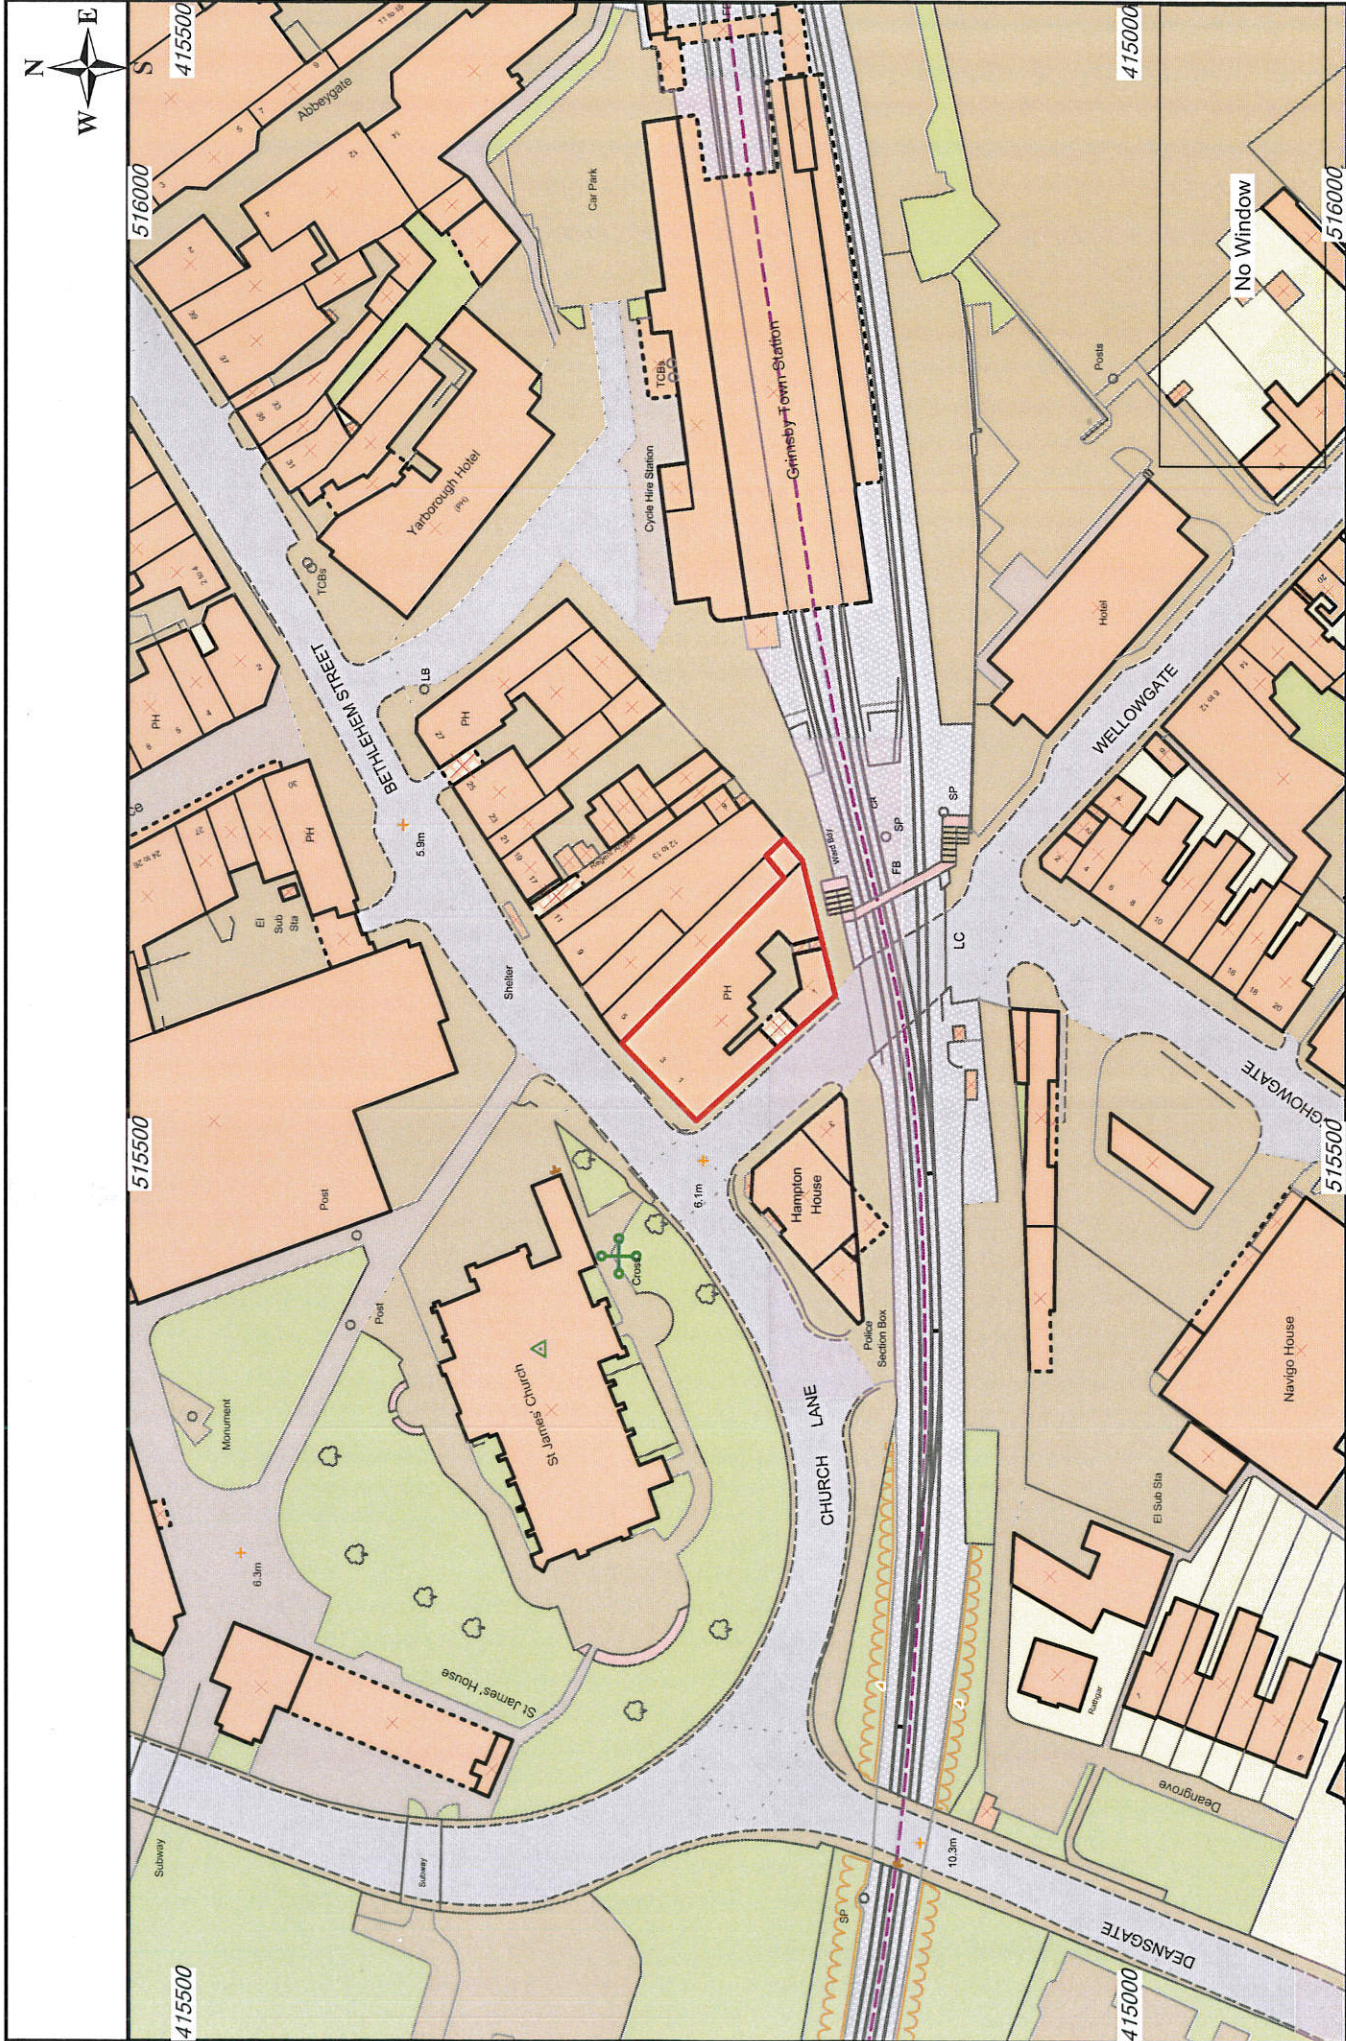
Painted SMOKEHOUSE sign

5.5 Remove current paint from the external render and masonry using an appropriate method following manufacturers guidelines. This includes removing the two hand painted smokehouse signs. Once clean and dry any holes or cracks in
