# Cast Iron Maintenance Guide

## Cleethorpes – North East Lincolnshire

A Maintenance Guide for Building Owners with Victorian Cast Iron Balconies and Structures within The Central Cleethorpes Seafront Conservation Area.

This guide has been developed as part of the Townscape Heritage Project for Cleethorpes funded by the National Lottery Heritage Fund

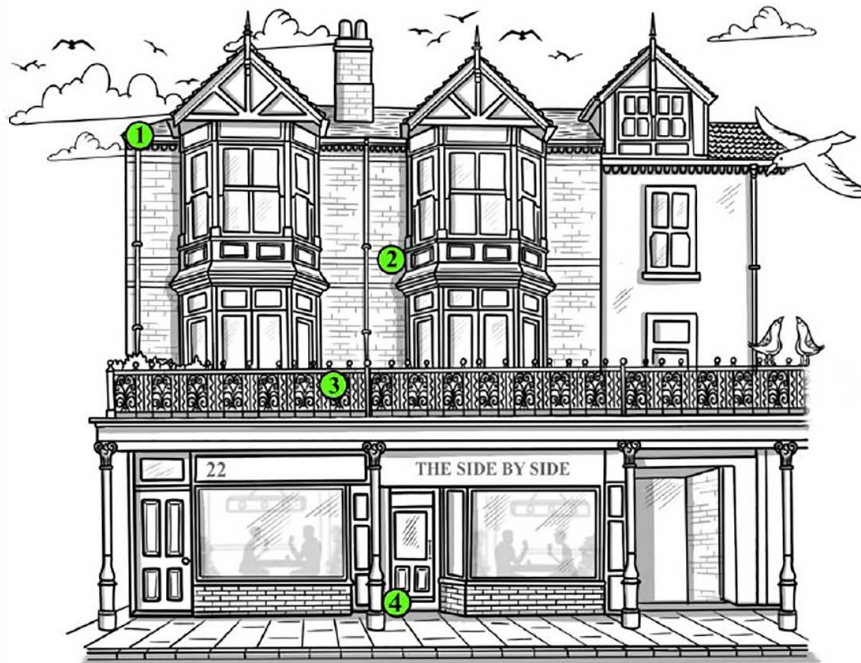
Balcony structures are attached to the main façade of a building, and in some cases, they facilitate the rainwater drainage from the guttering of the main building to drainage routes at ground level. Therefore, it is essential that the property guttering and downpipes are kept free of debris as water cascading over the guttering will not only accelerate deterioration of the timber and masonry of the main building, but it will also impact the balcony below.

Blocked downpipes are common and should be maintained as per the recommendations below, but it is essential and that work should be carried out in a safe manner. If in doubt, seek professional advice and guidance on how to carry out the work safely.

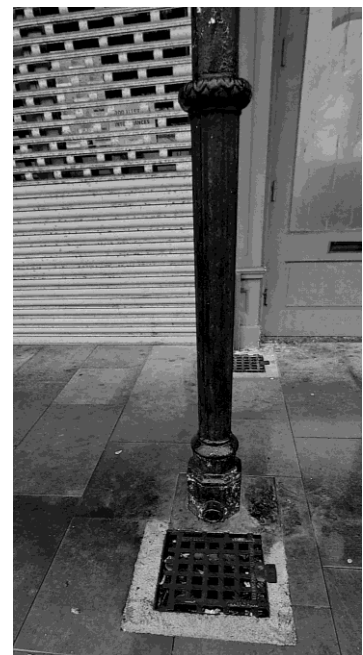
4. Depending on the design of cast iron, some of the front cast iron columns of the balcony act as rainwater outlets (downpipes), taking water from the decking above, see image as an example. Use the same approach as item 3 above to clear any blockages.

Other cast iron structures are likely to have standard cast iron guttering, but in some cases they too could have cast iron columns that act as downpipes.

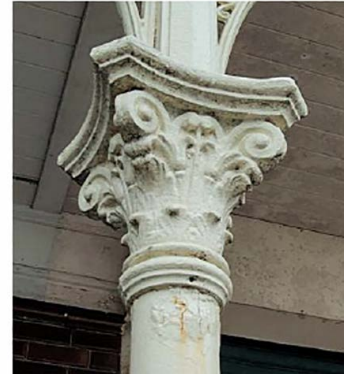
Paint failure is often the first sign that moisture is reaching the iron beneath. Rust spots or 'gingering' is caused by a break in the surface of the paint, exposing the metal to the marine environment, leading to corrosion. Early detection and remedial action are key to protecting the structures and saving money. They do not indicate a failure of the material but left untreated they could become a structural issue in the future.

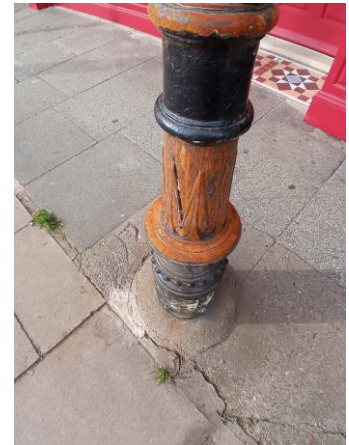
This recommended procedure is for preparing small areas of rust only. When carrying out maintenance, full scale stripping of paint in situ is not recommended due to the marine environment as the cast iron will react to the salt and rust very quickly. This example shows what can happen when the whole of the surface coating is taken back to bare metal.

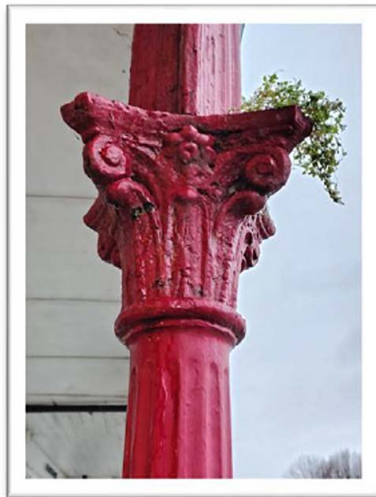
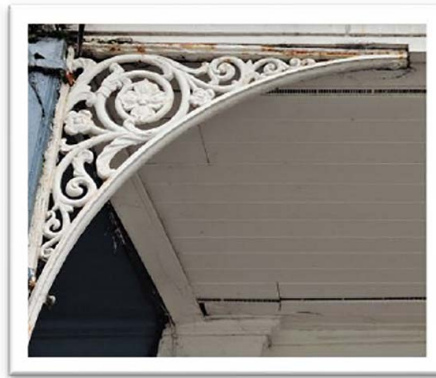
Examples of rust spotting and vegetation growth

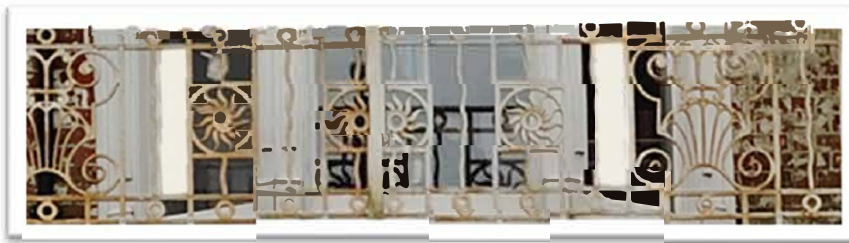
Example of cast iron which has been stripped back to the metal and not had the correct propriety coatings applied for a marine environment

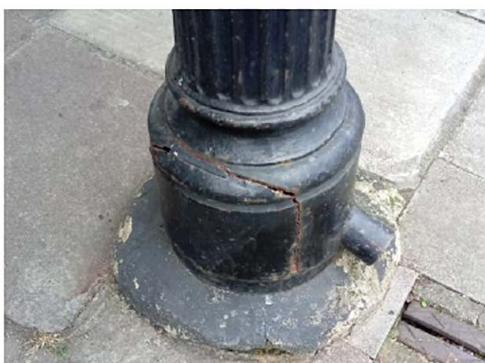
Example of fractured cast iron which required specialists to repair
